Report title: Corrosion test of anodized Al-name plates - Metalphoto	
Commission/project title:	
Client: Åge Børresen Stempelfabrikk A/S Hågasletta 11 3200 SANDEFJORD	Client's ref.: Åge Børresen Hans Kai Kristoffersen
Commission/project manager: Sofie Skjerve Helge Moving	Work carried out by: Kaare O Kristiansen, Kåre Malmberg, Helge Moving
External cooperation with:	Represented by:

23.1011.00.03.91

CORROSION TEST OF ANODIZED  
Al-NAME PLATES - METALPHOTO

COMMISSION REPORT

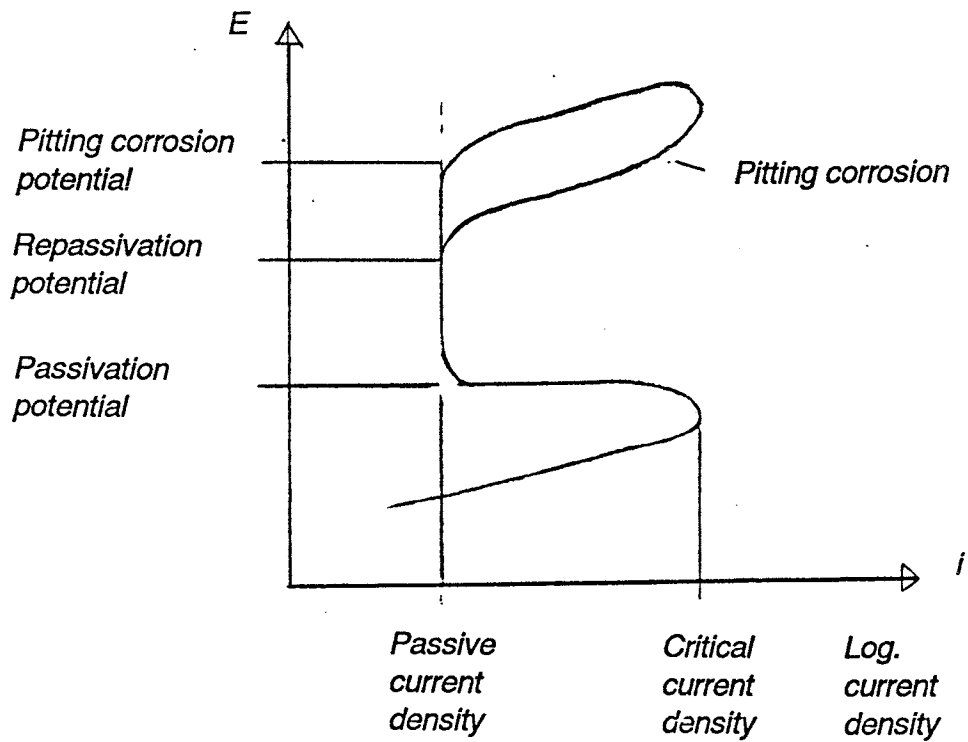
*Fig.1* : Anodic over voltage curve for an active – passive metal in an environment giving pitting corrosion.

Pitting corrosion develops on more or less passivated metals and alloys on corrosive mediums containing aggressive ions like e.g. chlorine and bromine. When the electrode potential in addition exceeds a critical value, the pitting corrosion potential, pitting corrosion is initiated. This is schematically shown in *fig. 1*.

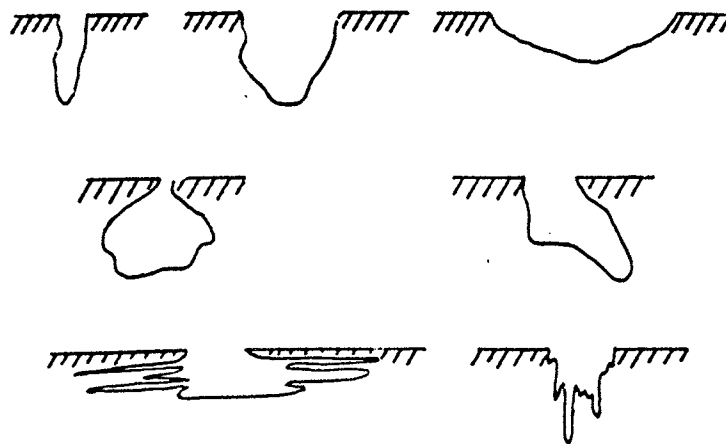
*Fig. 2.* : Various pit forms by pitting corrosion.

Pitting corrosion is characterized as narrow pits with a radius having the same size as the depth of the pit or smaller. The pits can have various forms but a common characteristic is the sharp border line that it forms to the remaining passive metal surface. See also *fig.2*.

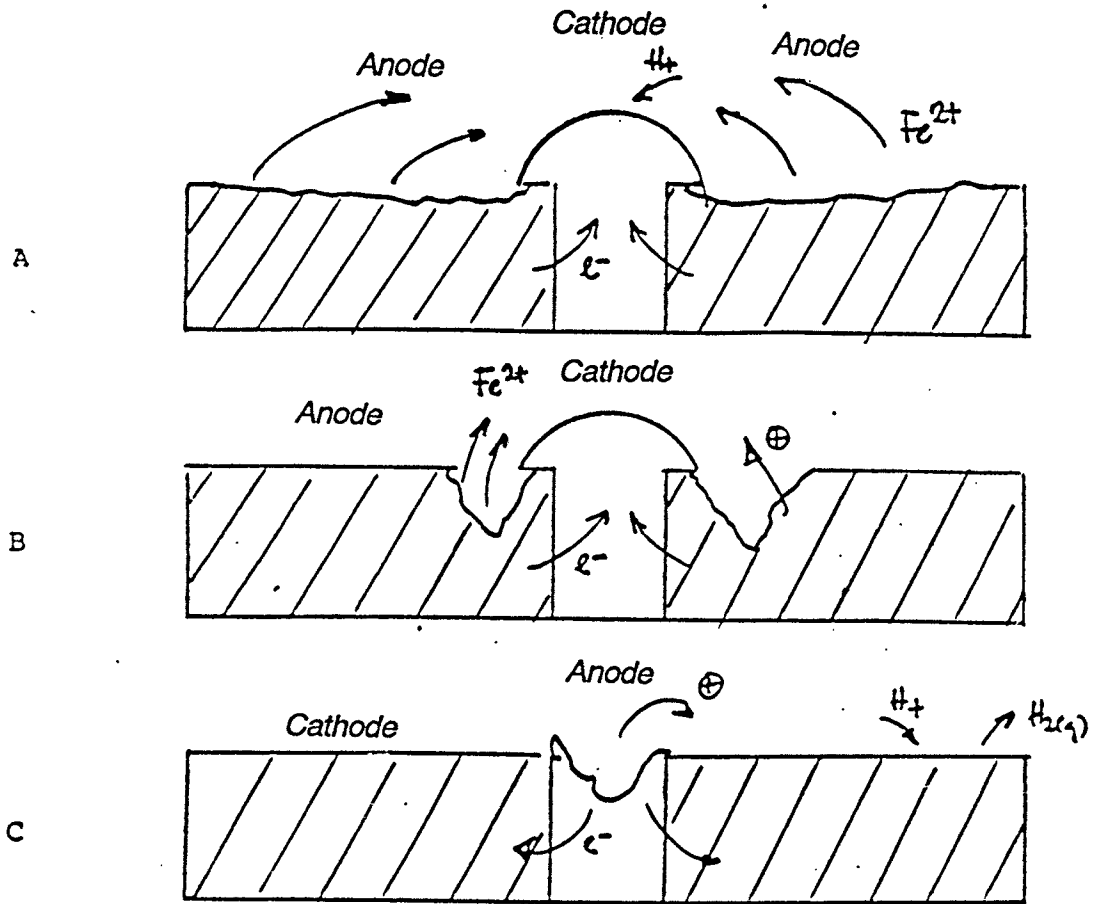
Fig. 3 : Galvanic corrosion: screw and plate made of different materials.

- A. Shows a noble screw, a less noble plate and an electrolyte with a conductive substance.
- B. Shows a noble screw, a less noble plate and an electrolyte with a not so good conductive substance.
- C. Shows a noble plate and a less noble screw.

Fig. 3 shows examples of galvanic corrosion.

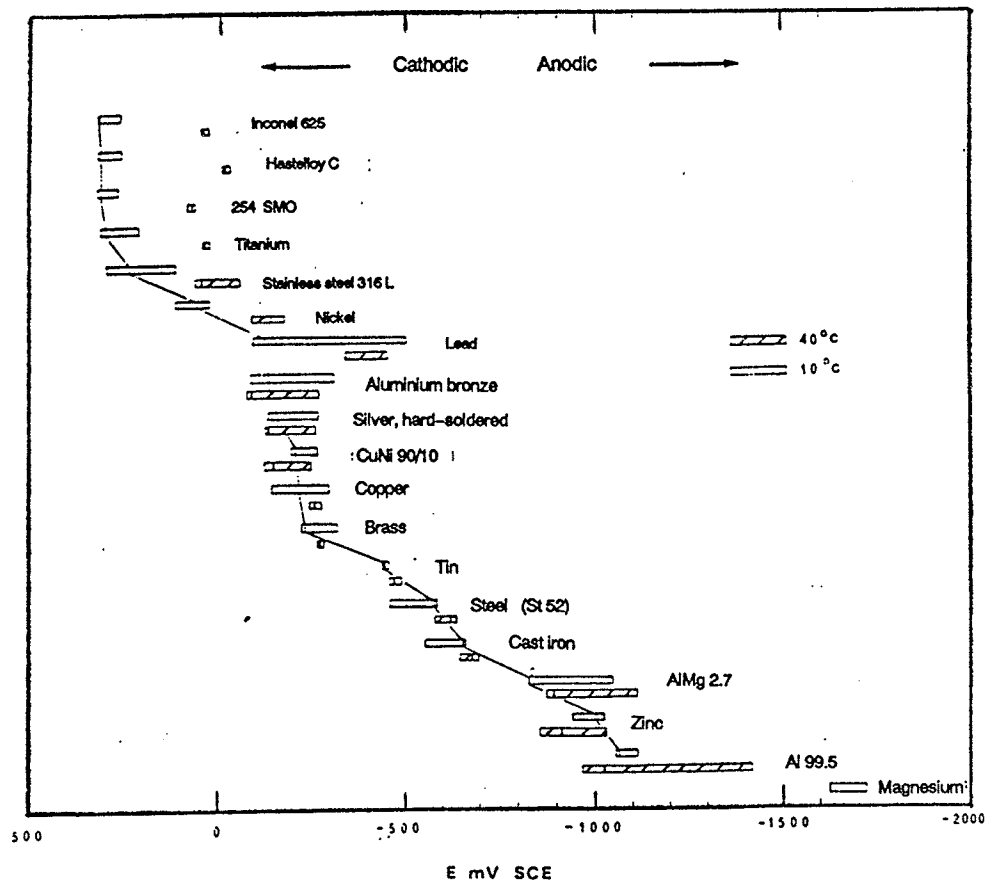
Fig. 4 : Galvanic series for sea water at 10 °C and 40 °C. The materials have been arranged due to the average values of the corrosion potentials shown during the last 10 days of exposure at 10 °C. The rectangles show the variation during the significant part of the exposure time [2].

The risk for galvanic corrosion can partly be anticipated when using a galvanic series. A practical galvanic series showing the corrosion potential for different metals in sea water is given in fig. 4 /2/.

If no more complete data exists the galvanic series for the actual environment can be used in the following way:

- a. When  $\Delta E_{korr}$  (i.e. the difference in the corrosion potential for two different kinds of materials)  $< 50$  mV for two materials the connection will only cause minor changes in the corrosion rate (i.e. if the relation between the areas of the anode and the cathode is not very unfavourable or if the less noble material is exposed to a definite local corrosion, e.g. pitting corrosion).

b. When  $\Delta E_{\text{korr}} > 50 \text{ mV}$  there is a risk that the less noble material might corrode faster after being connected to the noble material. It should be mentioned that the potential difference between the metals is not a reliable tool for calculating the corrosion rate increase.

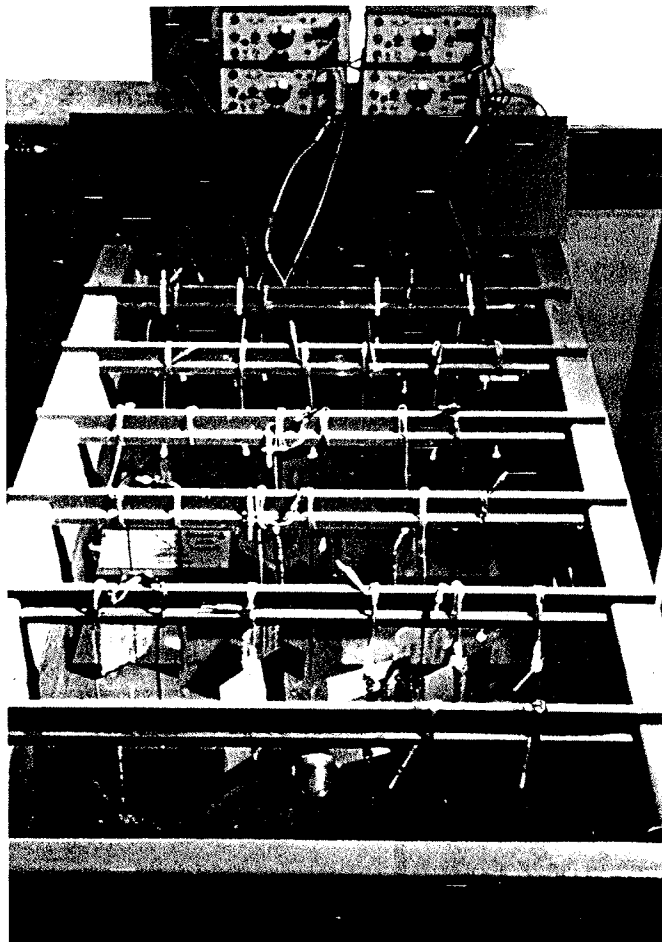
Photograph No 1: Name plate exposed in sea water.

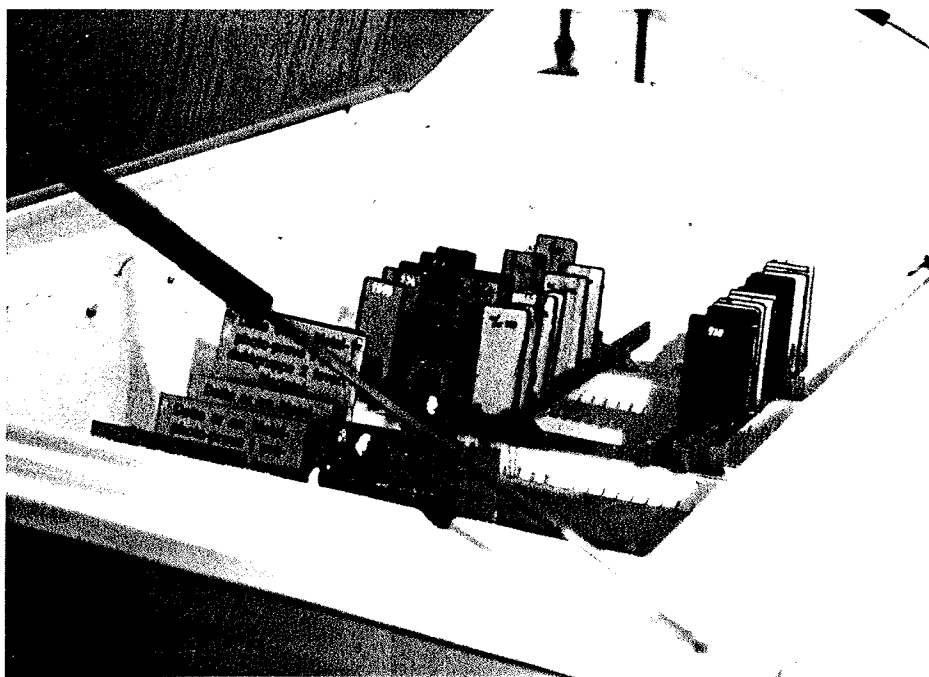
Photograph No 2: Name plate exposed in salt spray chamber.

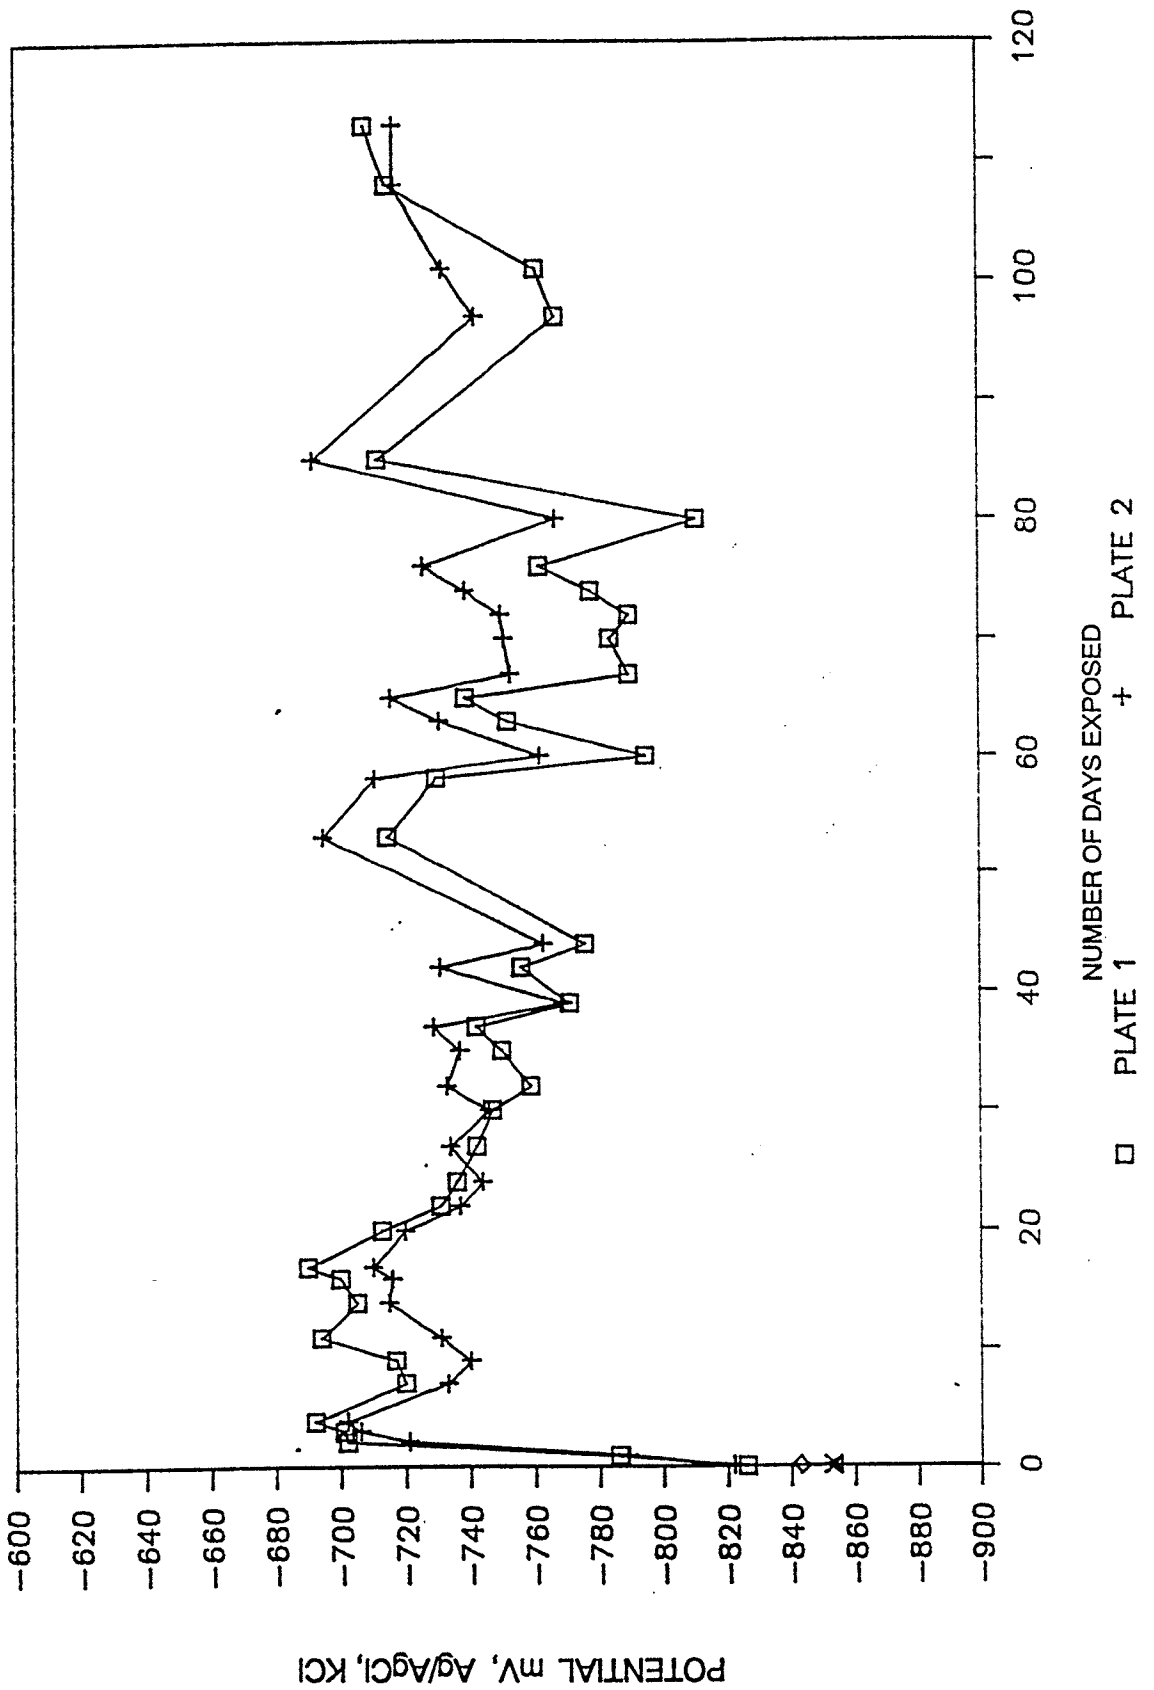
# MEASURING OF POTENTIAL, AI-NAME PLATES WITHOUT DEFECT

The aluminium plates which were exposed under free corrosion showed potential values in the region from –840 to –620 mV with an average of approximately –720 mV (see figures 7 – 14 + figure 18).

All the freely exposed plates had at least on one occasion reached –670 mV (the pitting potential). This implied that pitting corrosion could have been initiated on all plates. At the visual inspection pitting corrosion was found on all plates with the exception of the plates with the insulated edges ( plates 42 – 43). These plates showed no pitting at all. All the pitting was found along the edges of the plate and the pits were roughly of the same size on all the freely exposed plates. The attacks were, however, so small that a magnifying glass had to be used to detect the pits. When using a microscope the maximum depth of the pits was established to be 40  $\mu\text{m}$ .

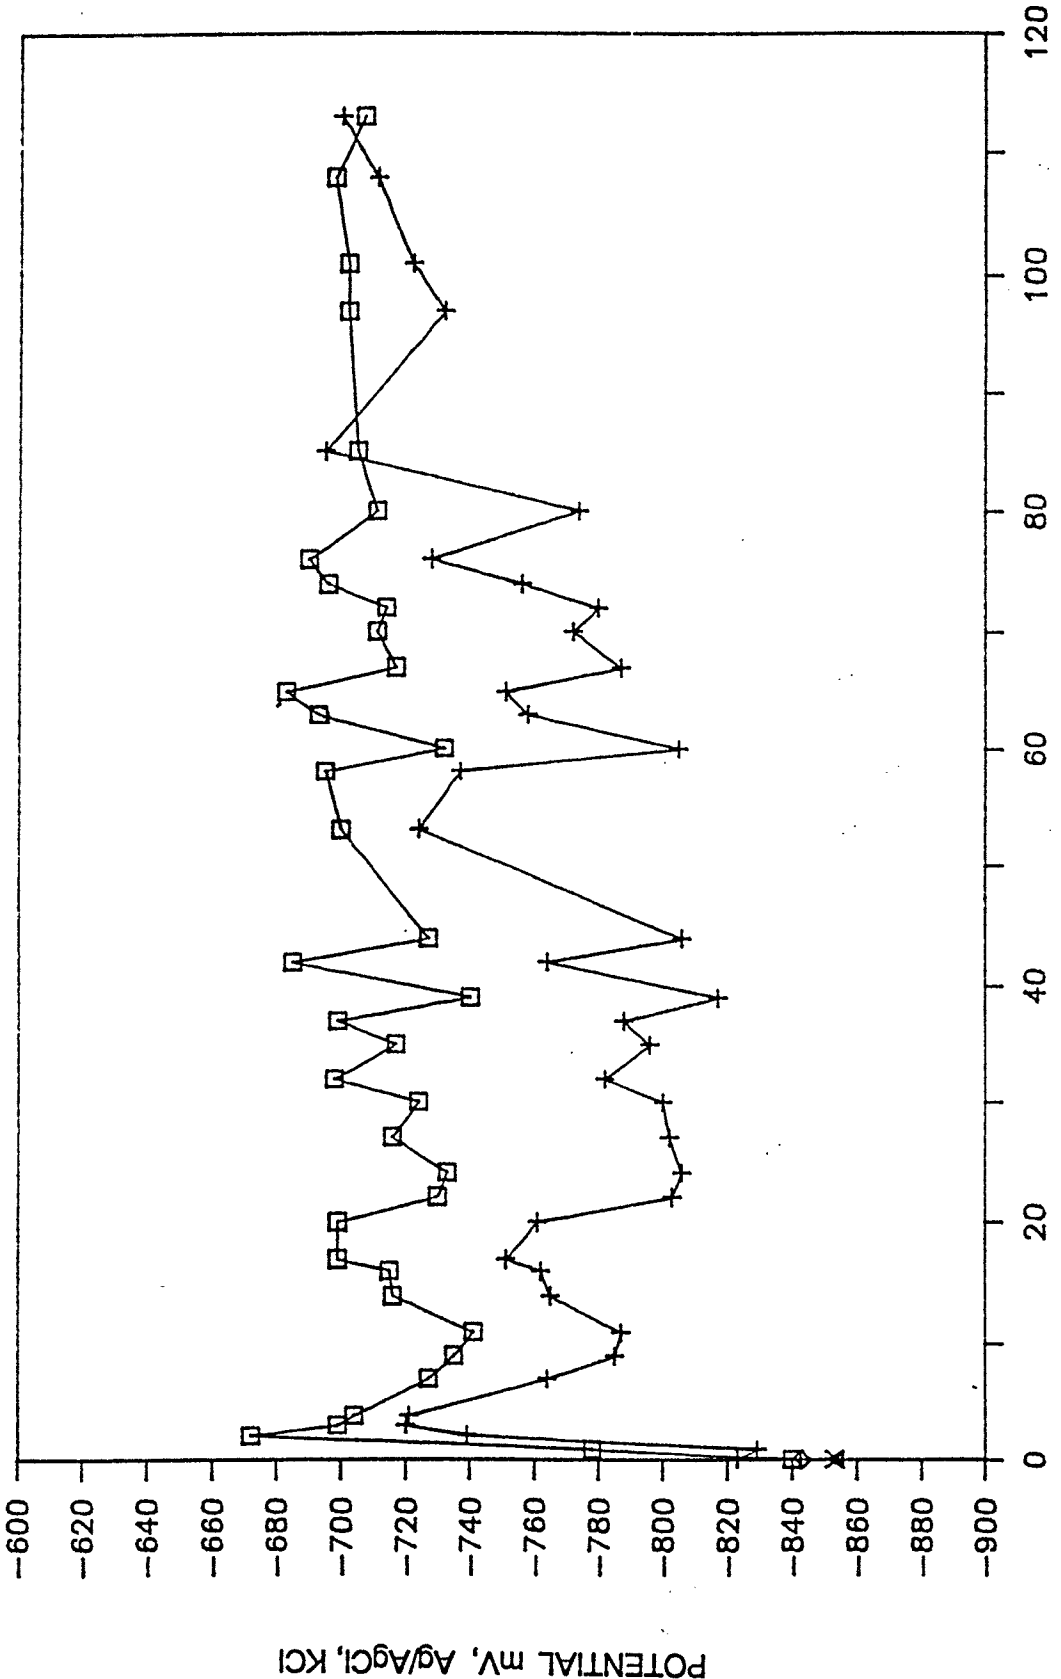
<p>NORWEGIAN MARINE TECHNOLOGY RESEARCH INSTITUTE A/S</p>	PROJECT NO.
	REPORT NO.
	FIGURE NO. 8

# MEASURING OF POTENTIAL, AI-NAME PLATES

WITH SCRATCH

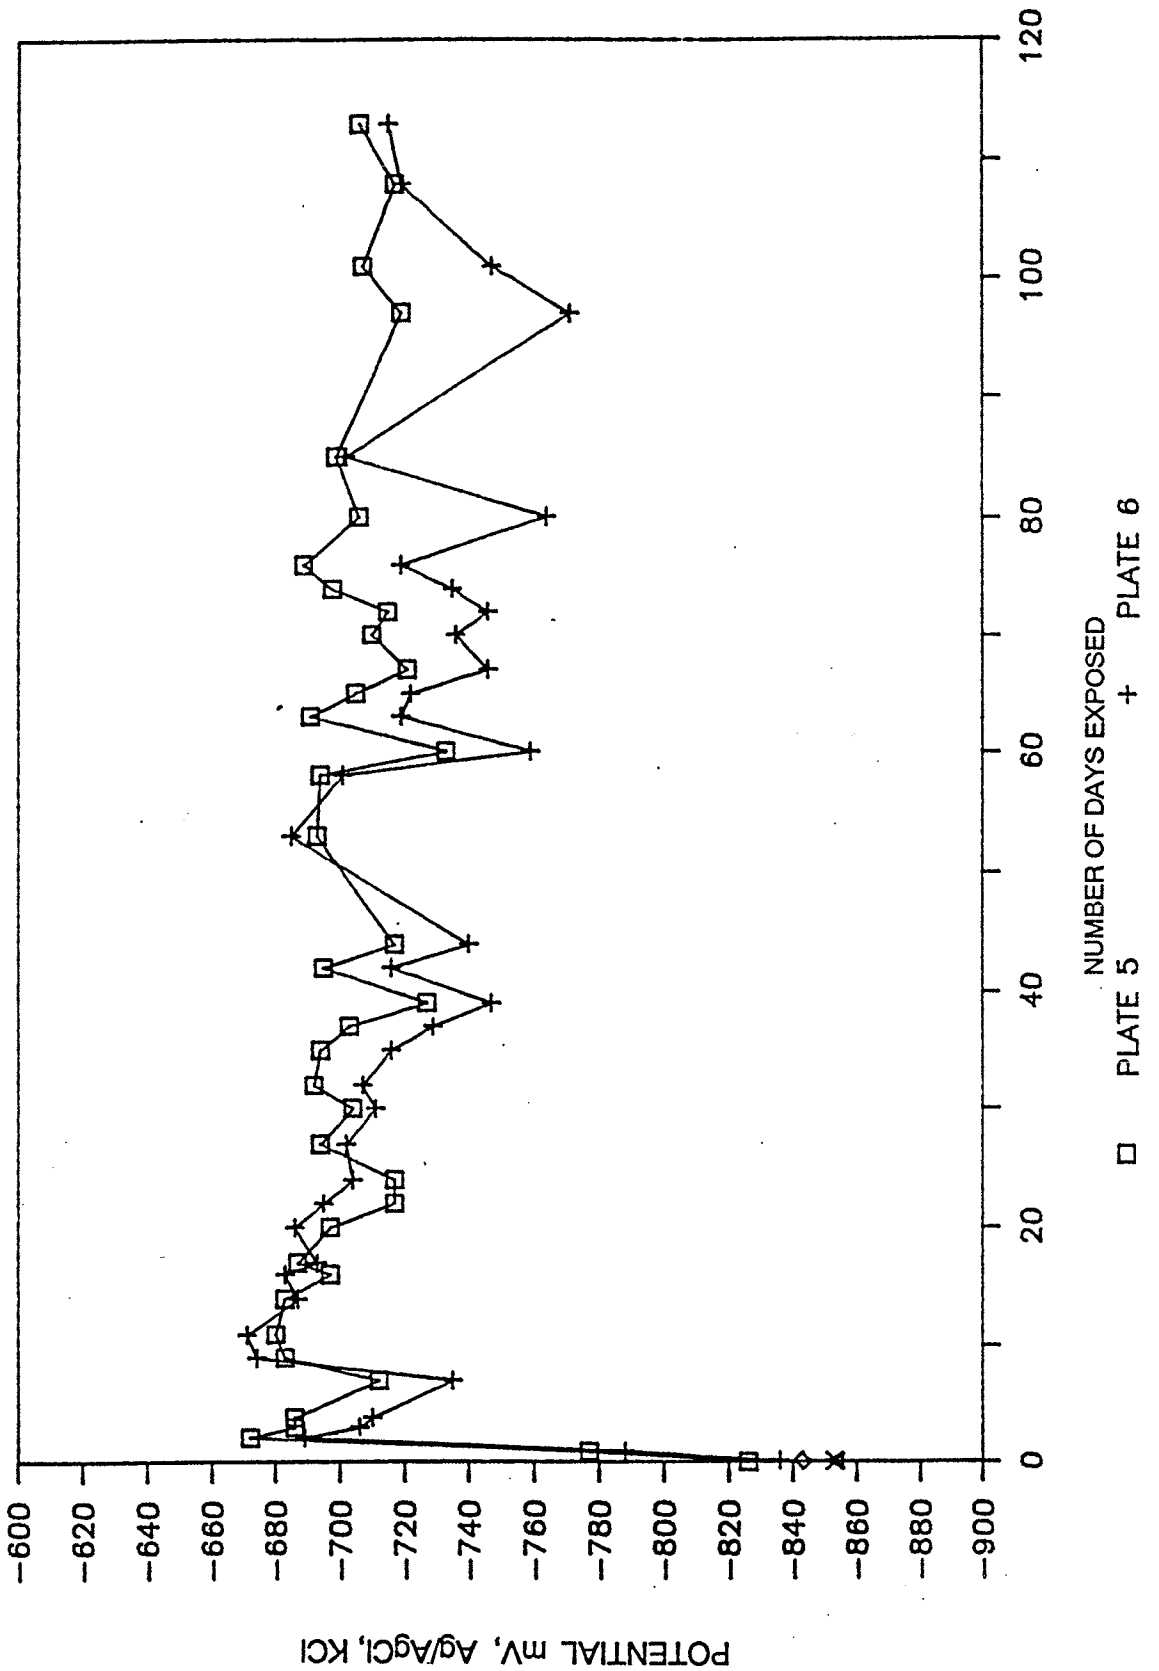
PROJECT NO.
REPORT NO.
FIGURE NO. 9

# MEASURING OF POTENTIAL, AI-NAME PLATES

WITH MACHINED DEFECT

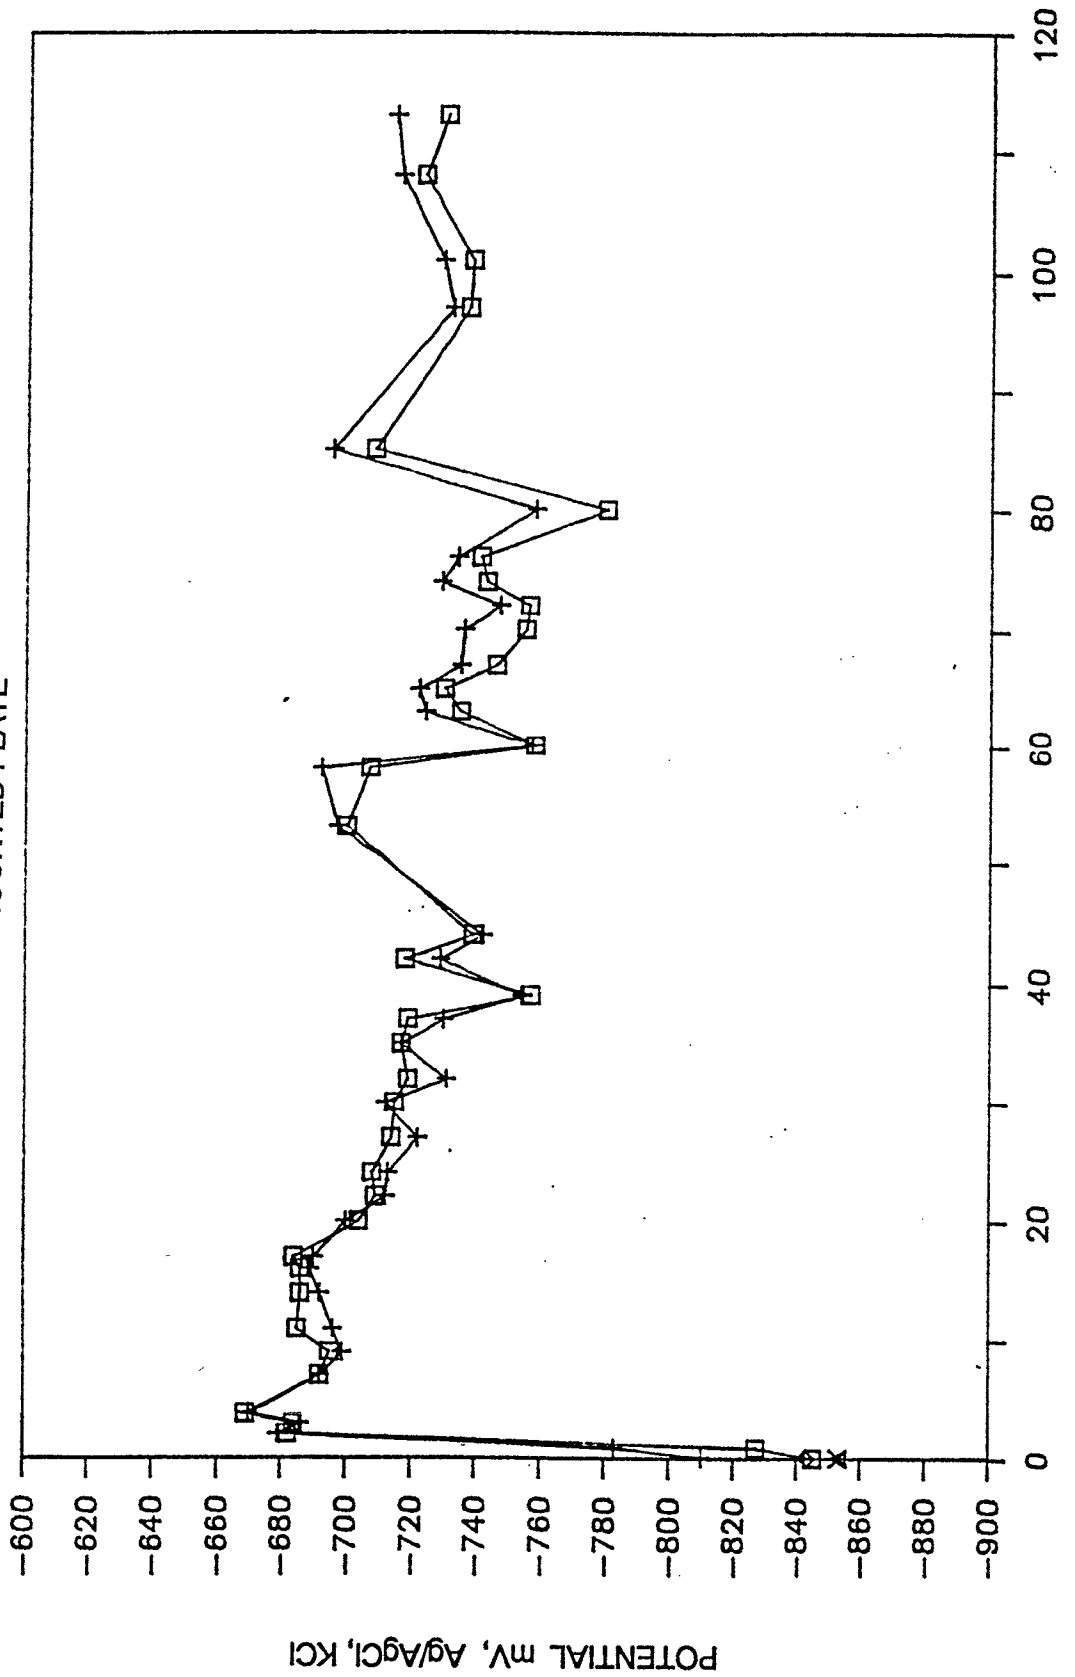
NORWEGIAN MARINE TECHNOLOGY RESEARCH INSTITUTE A/S	PROJECT NO.
	REPORT NO.
	FIGURE NO. 10

# MEASURING OF POTENTIAL, AI-NAME PLATES

MOUNTED PLATE

The mounted plates also only had suggestions of pit corrosion along the edges but these plates showed a significantly greater loss of weight than the other freely exposed plates. The reason for this was that the back sides of the mounted plates were equipped with double-sided tape before exposure. During the exposure this tape partly dissolved resulting in the higher loss of weight.

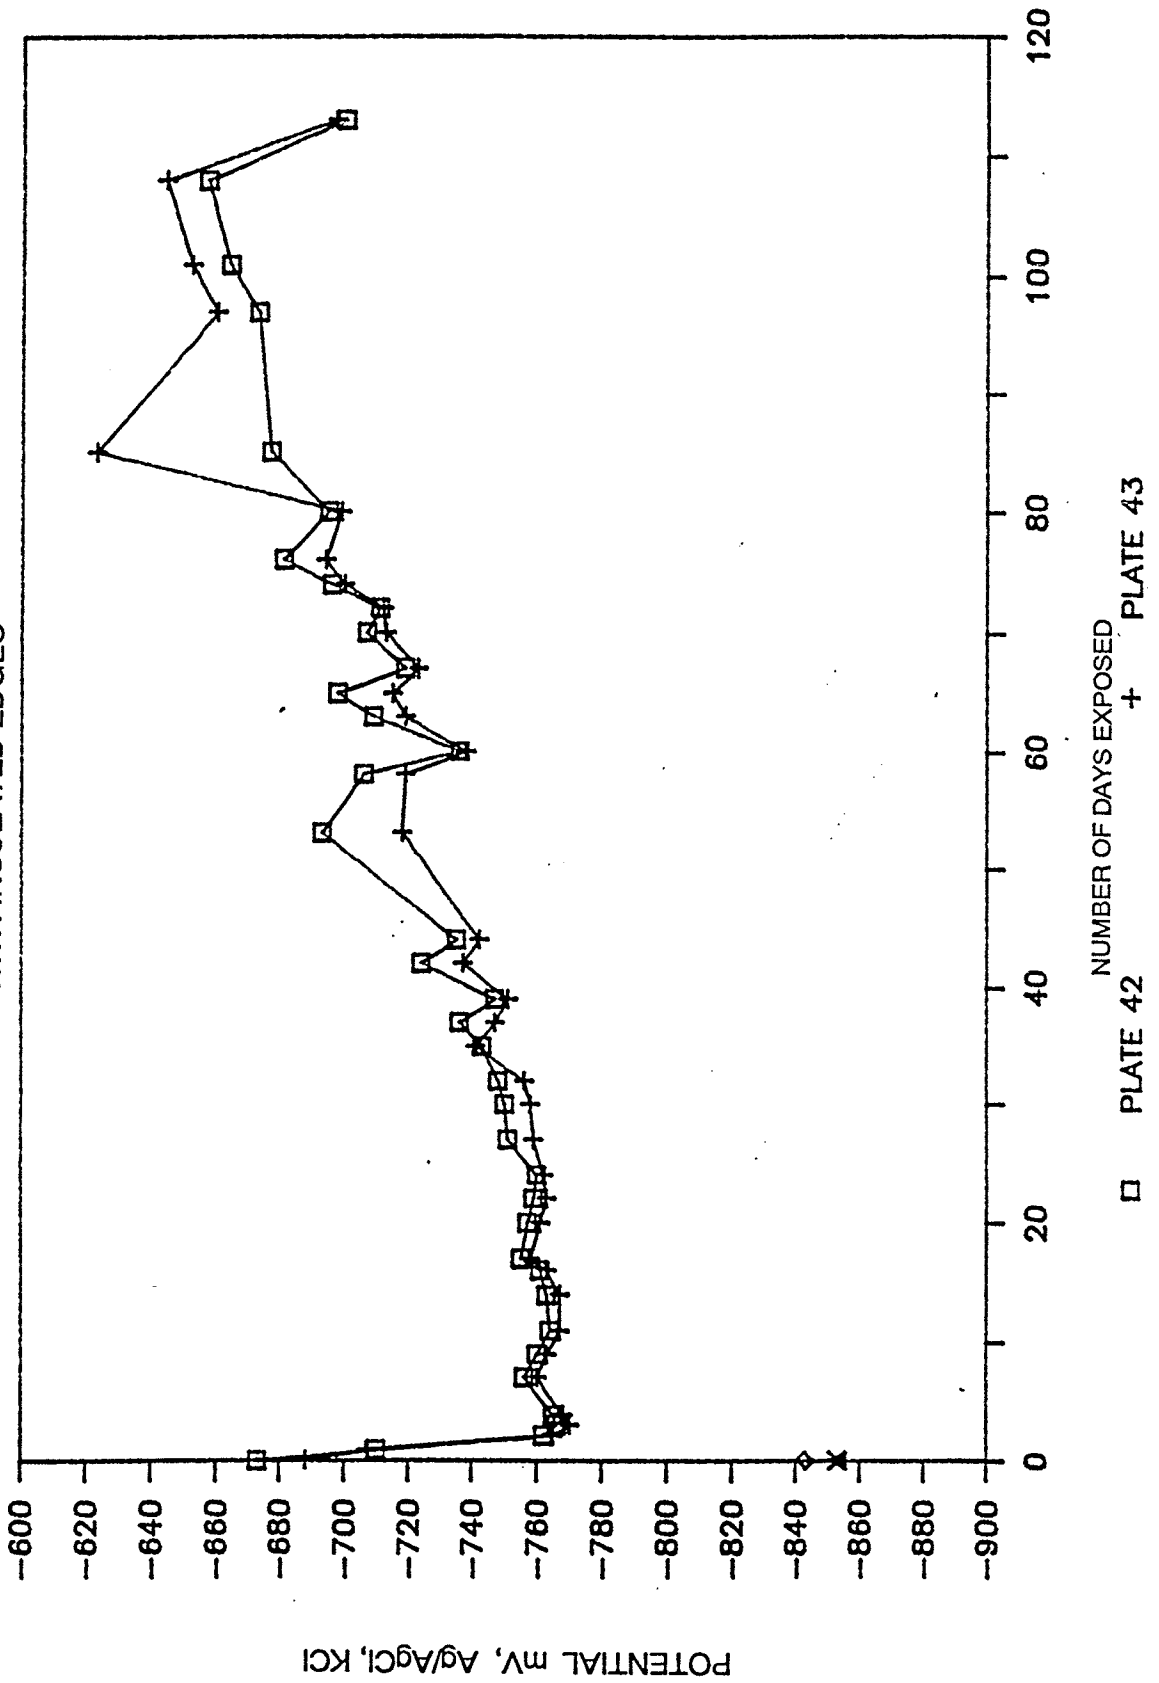
NORWEGIAN MARINE TECHNOLOGY RESEARCH INSTITUTE A/S	PROJECT NO.
	REPORT NO.
	FIGURE NO. 11

# MEASURING OF POTENTIAL, AI-NAME PLATES

WITH INSULATED EDGES

The corrosion conditions for the plates were improved when the cut edges were insulated by the use of a vinyl tar painting system. We could not find any corrosion attacks on these plates even though the potential on one of the plates was all the way up to  $-620$  mV. Such a potential normally means that pitting corrosion can be initiated but the paint that was used to insulate the edges does effect the potential measuring. To what extent the potential can be influenced depends on the insulating effect of the painting system and it can therefore be difficult to evaluate the potential directly.

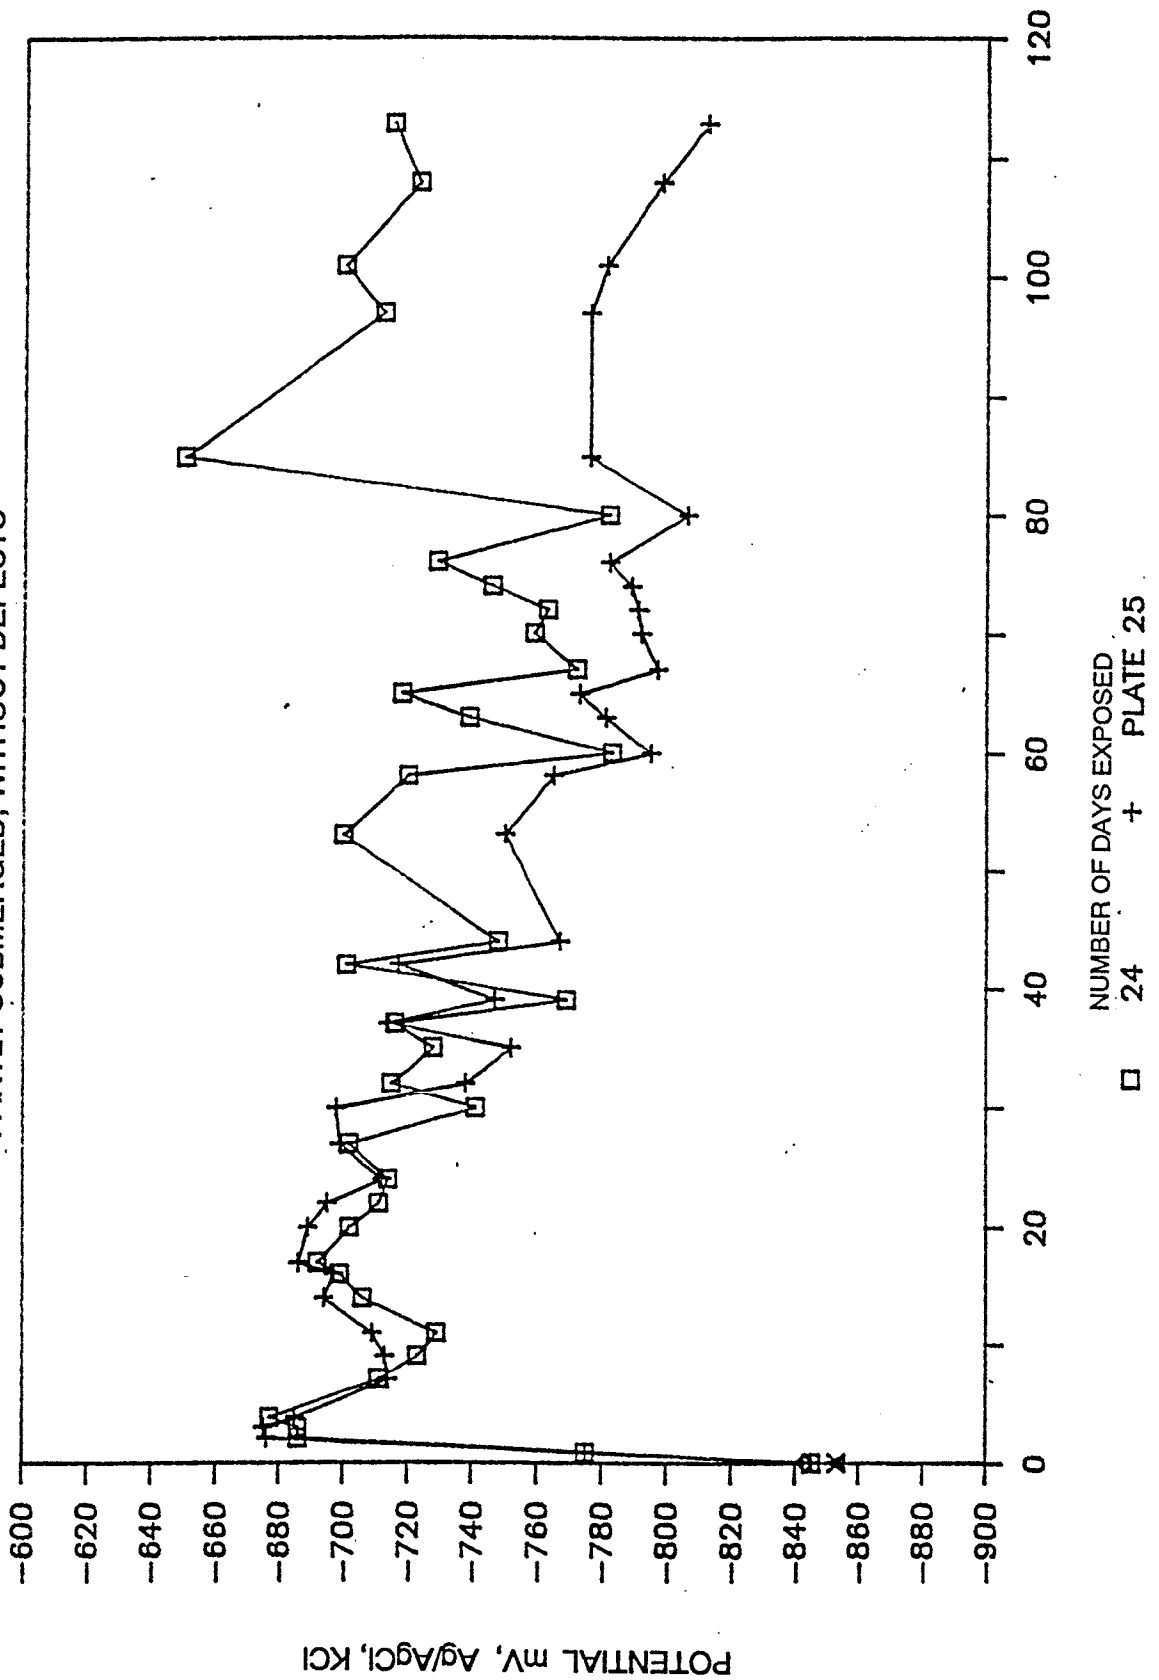
NORWEGIAN MARINE TECHNOLOGY RESEARCH INSTITUTE A/S	PROJECT NO.
	REPORT NO.
	FIGURE NO. 12

# MEASURING OF POTENTIAL, AI-NAME PLATES

PARTLY SUBMERGED, WITHOUT DEFECTS

The partly submerged plates showed exactly the same corrosion pattern as the completely submerged ones. The potential development was the same (see figures 12 – 14) in both cases and there were only suggestions of pit corrosion along the edges of the plates, approx. 70  $\mu\text{m}$ .

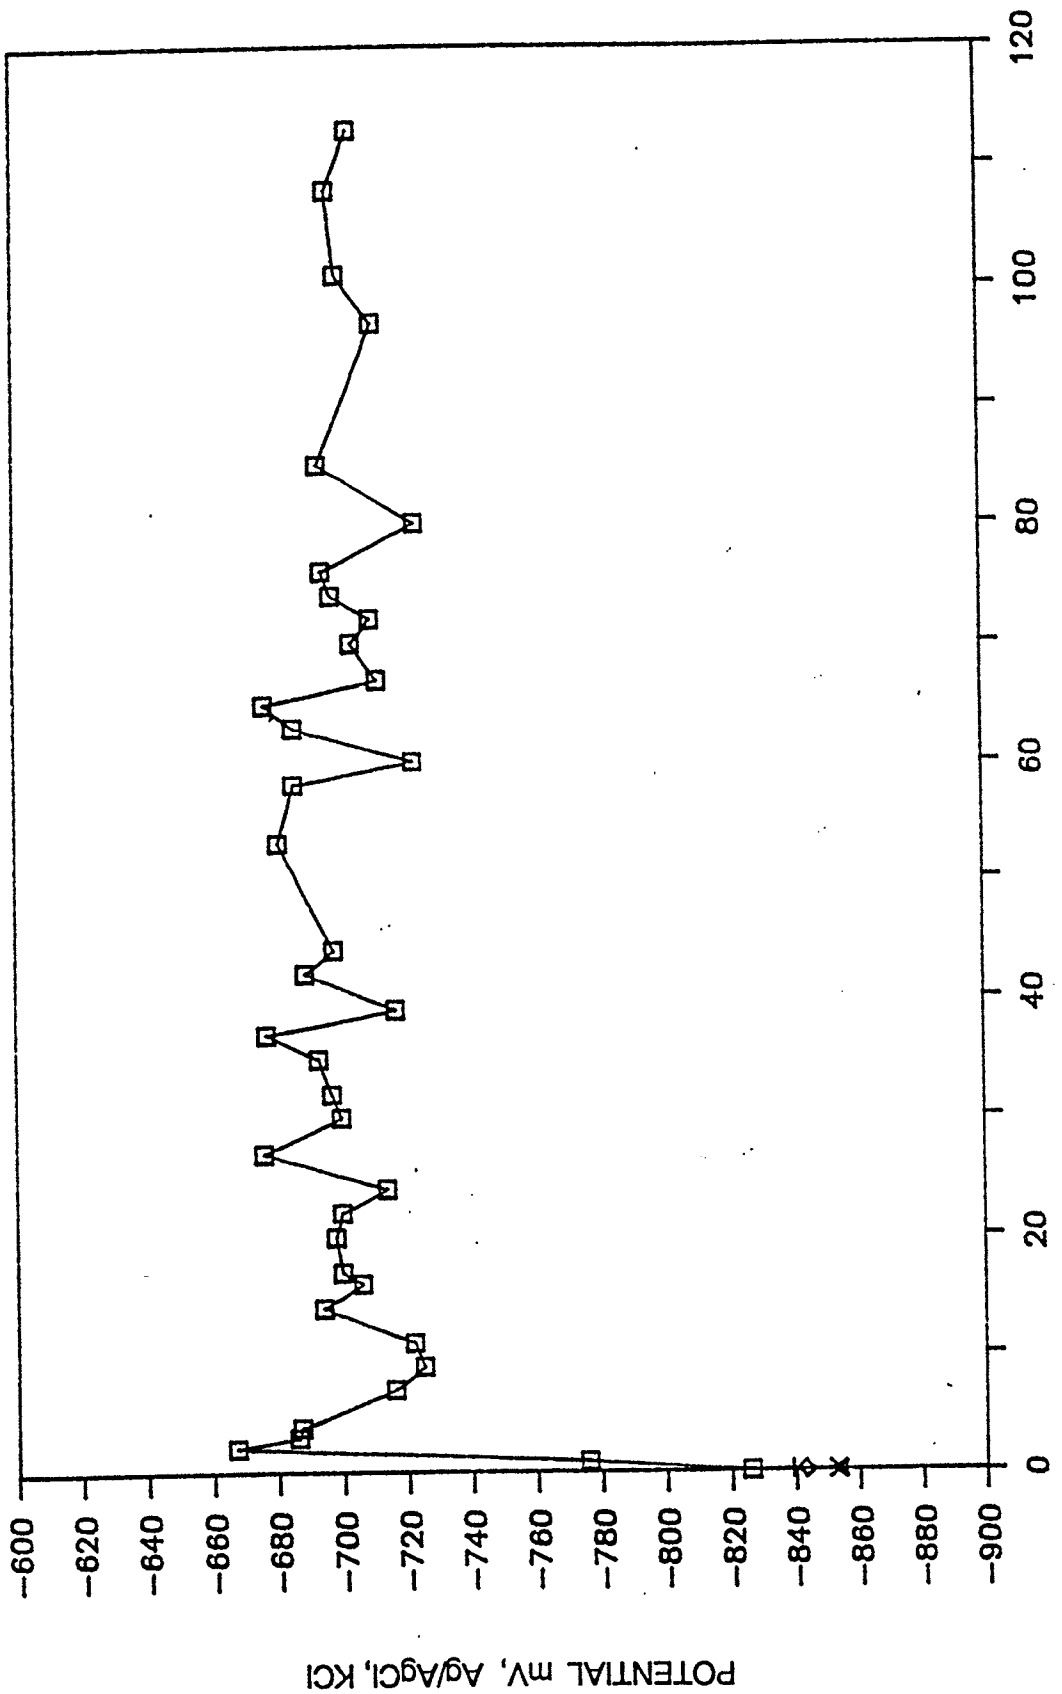
# MEASURING OF POTENTIAL, AI-NAME PLATES

PARTLY SUBMERGED, WITH SCRATCH

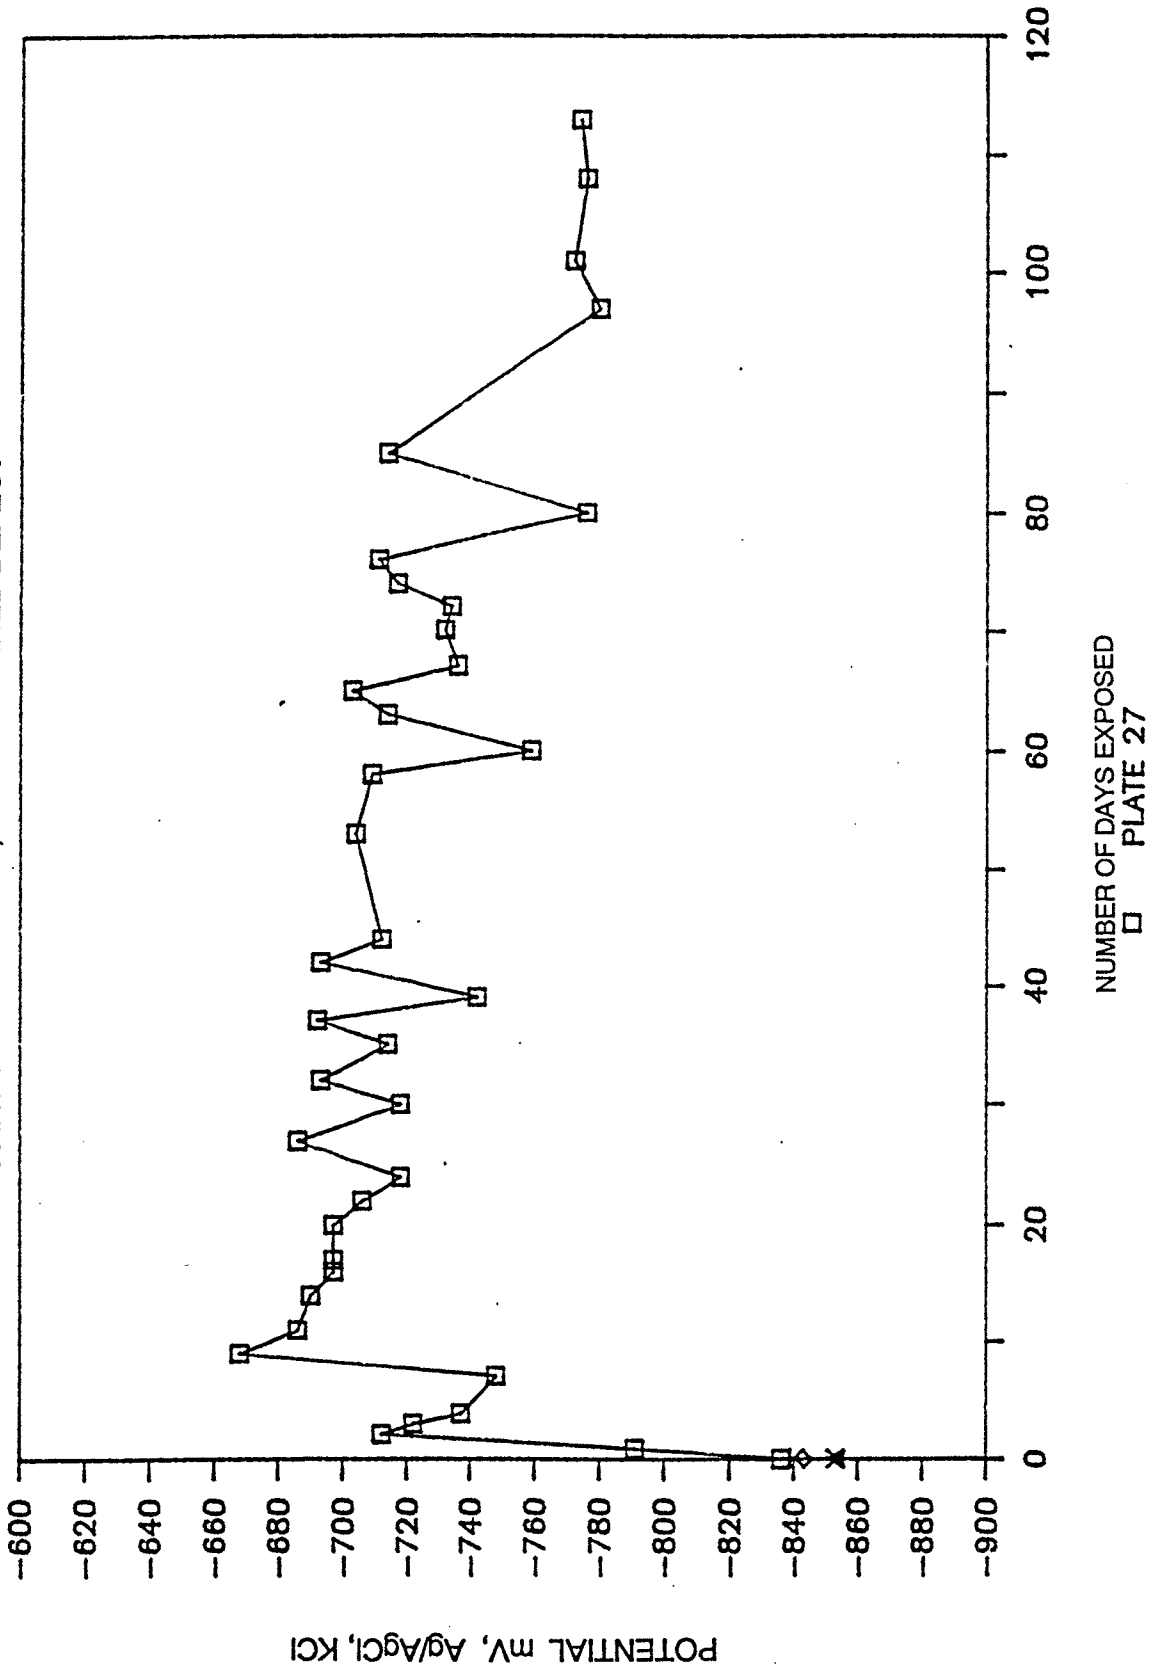
NORWEGIAN MARINE TECHNOLOGY RESEARCH INSTITUTE A/S	PROJECT NO.
	REPORT NO.
	FIGURE NO. 14

# MEASURING OF POTENTIAL, AI-NAME PLATES

PARTLY SUBMERGED, WITH MACHINED DEFECT

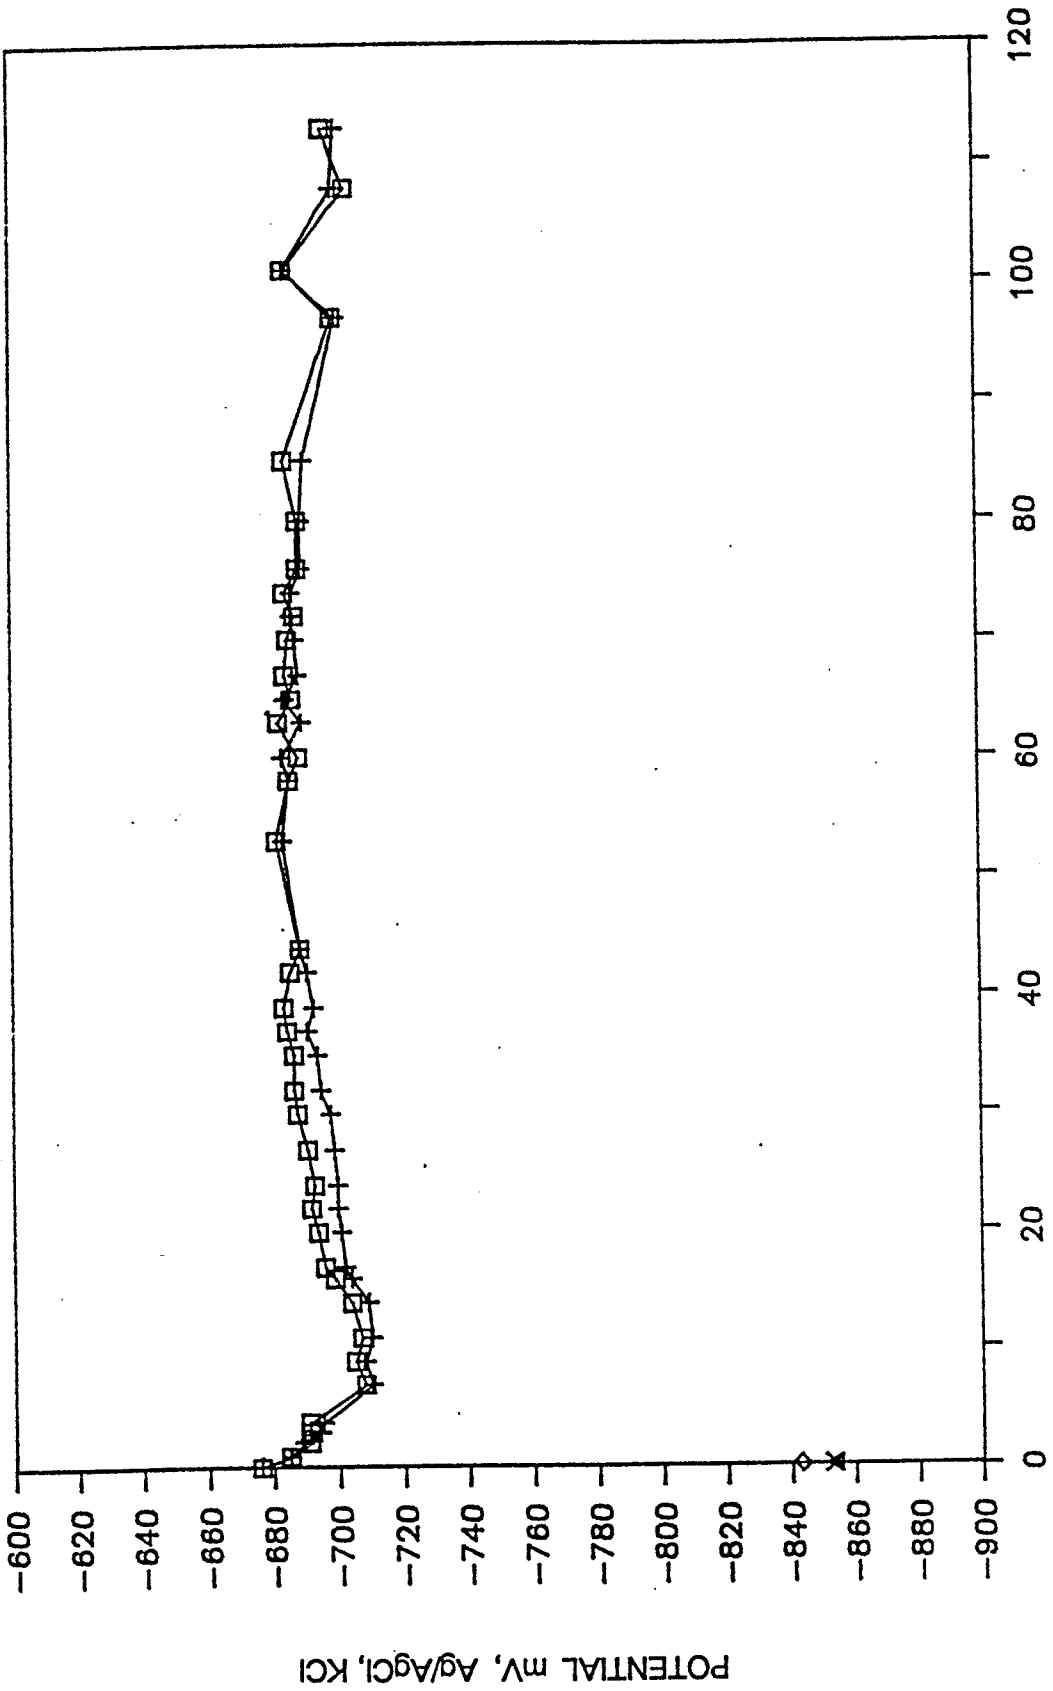
<p>NORWEGIAN MARINE TECHNOLOGY RESEARCH INSTITUTE A/S</p>	PROJECT NO.
	REPORT NO.
	FIGURE NO. 15

# MEASURING OF POTENTIAL, AI-NAME PLATES

GALVANICALLY COUPLED TO CARBON STEEL, WITHOUT DEFECT

The aluminium plates that were connected to steel showed a stable potential development progress (see figures 15 – 17). Figures 19 – 21 show the current density development for galvanic connected plates with various kinds of created defects. The current density is here an expression for the corrosion rate for this particular aluminium. This means that the higher the current density the more powerful the corrosion attack. This depends on the fact that the aluminium plates (edges + created defects) act like a sacrificial anode when they are connected to the steel plate. You can also note that the current density increases over time.
