Report title: Corrosion test of anodized Al-name plates - Metalphoto	
Commission/project title:	
Client: Åge Børresen Stempelfabrikk A/S Hågasletta 11 3200 SANDEFJORD	Client's ref.: Åge Børresen Hans Kai Kristoffersen
Commission/project manager: Sofie Skjerve Helge Moving	Work carried out by: Kaare O Kristiansen, Kåre Malmberg, Helge Moving
External cooperation with:	Represented by:

23.1011.00.03.91

CORROSION TEST OF ANODIZED  
Al-NAME PLATES - METALPHOTO

COMMISSION REPORT

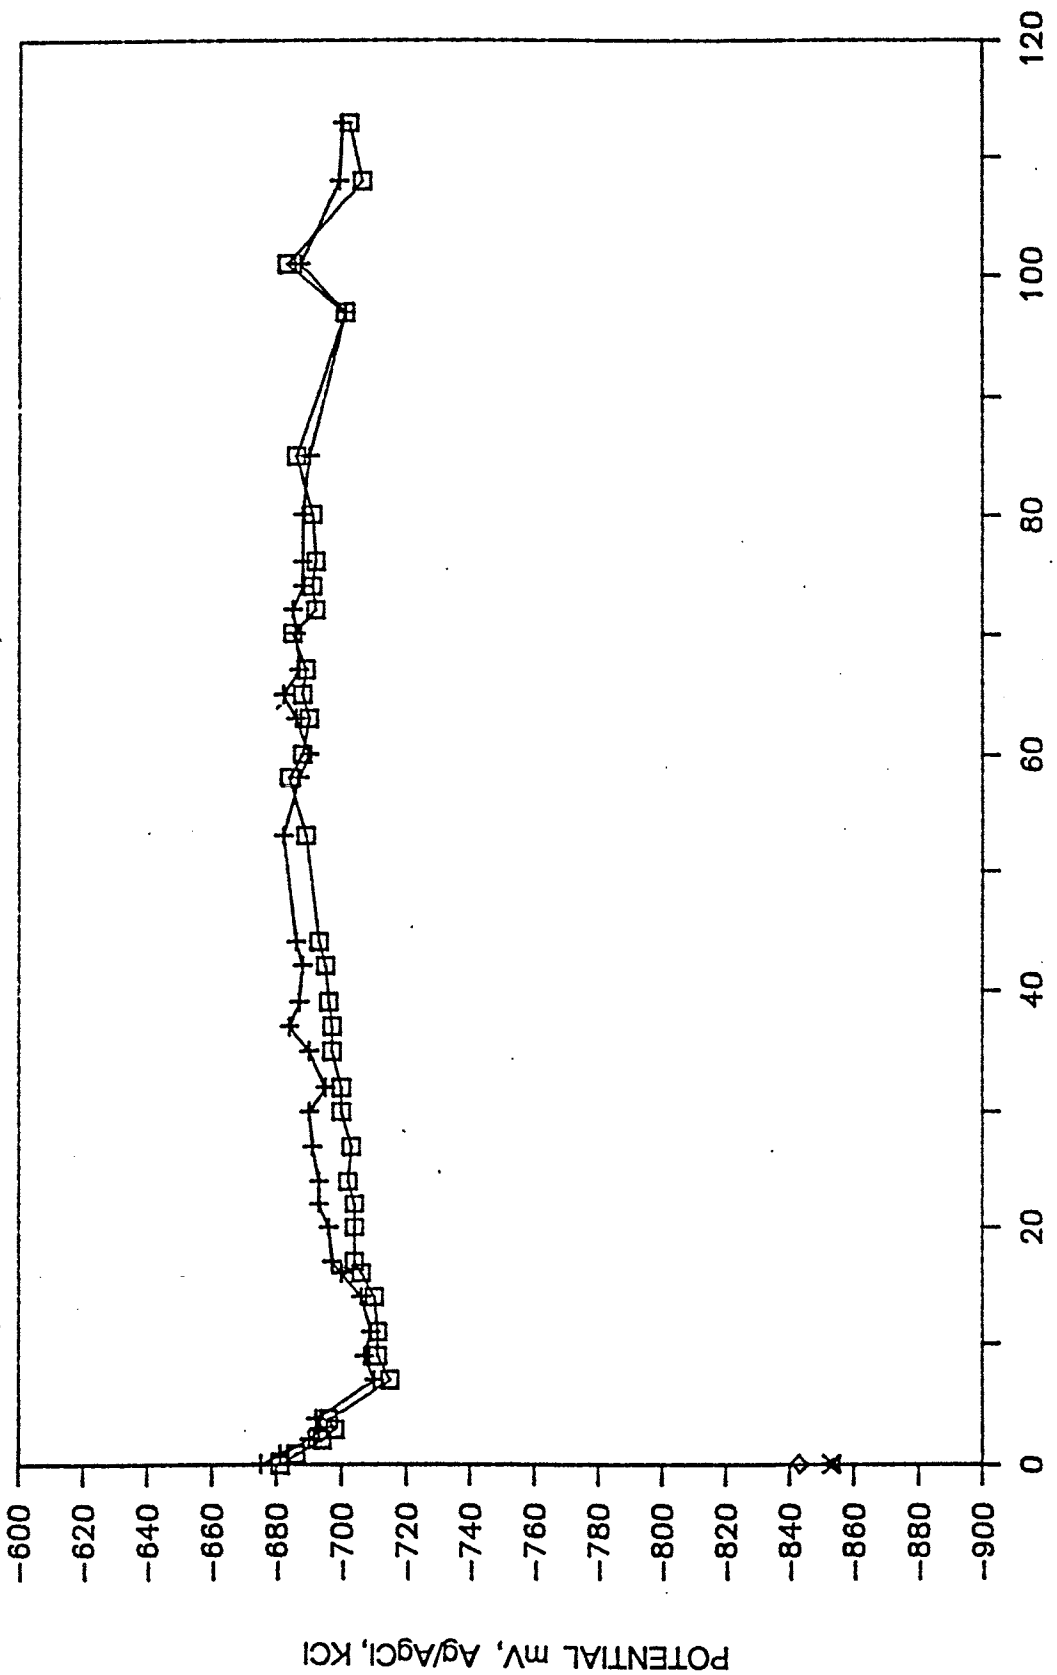
NORWEGIAN MARINE TECHNOLOGY RESEARCH INSTITUTE A/S	PROJECT NO.
	REPORT NO.
	FIGURE NO. 16

# MEASURING OF POTENTIAL, AI-NAME PLATES

GALVANICALLY COUPLED TO CARBON STEEL, WITH SCRATCH

The aluminium plates that were connected to steel showed a stable potential development progress (see figures 15 – 17). Figures 19 – 21 show the current density development for galvanic connected plates with various kinds of created defects. The current density is here an expression for the corrosion rate for this particular aluminium. This means that the higher the current density the more powerful the corrosion attack. This depends on the fact that the aluminium plates (edges + created defects) act like a sacrificial anode when they are connected to the steel plate. You can also note that the current density increases over time.

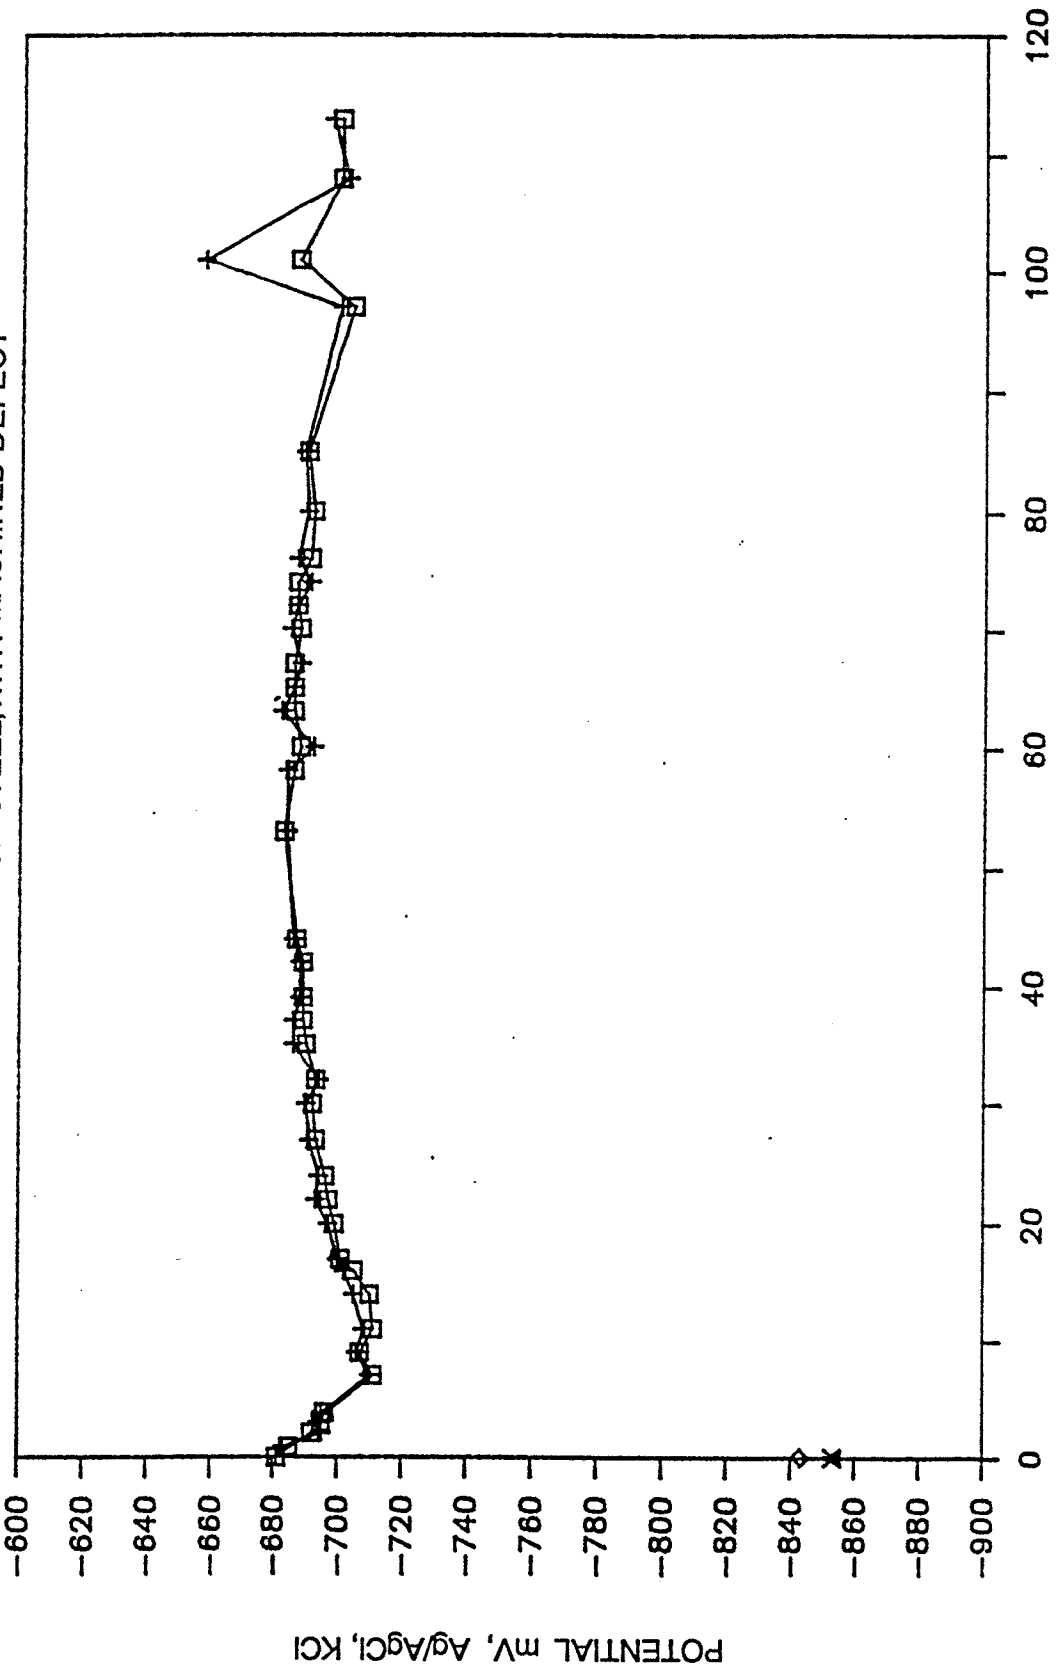
NORWEGIAN MARINE TECHNOLOGY RESEARCH INSTITUTE A/S	PROJECT NO.
	REPORT NO.
	FIGURE NO. 17

# MEASURING OF POTENTIAL, AI-NAME PLATES

GALVANICALLY COUPLED TO CARBON STEEL, WITH MACHINED DEFECT

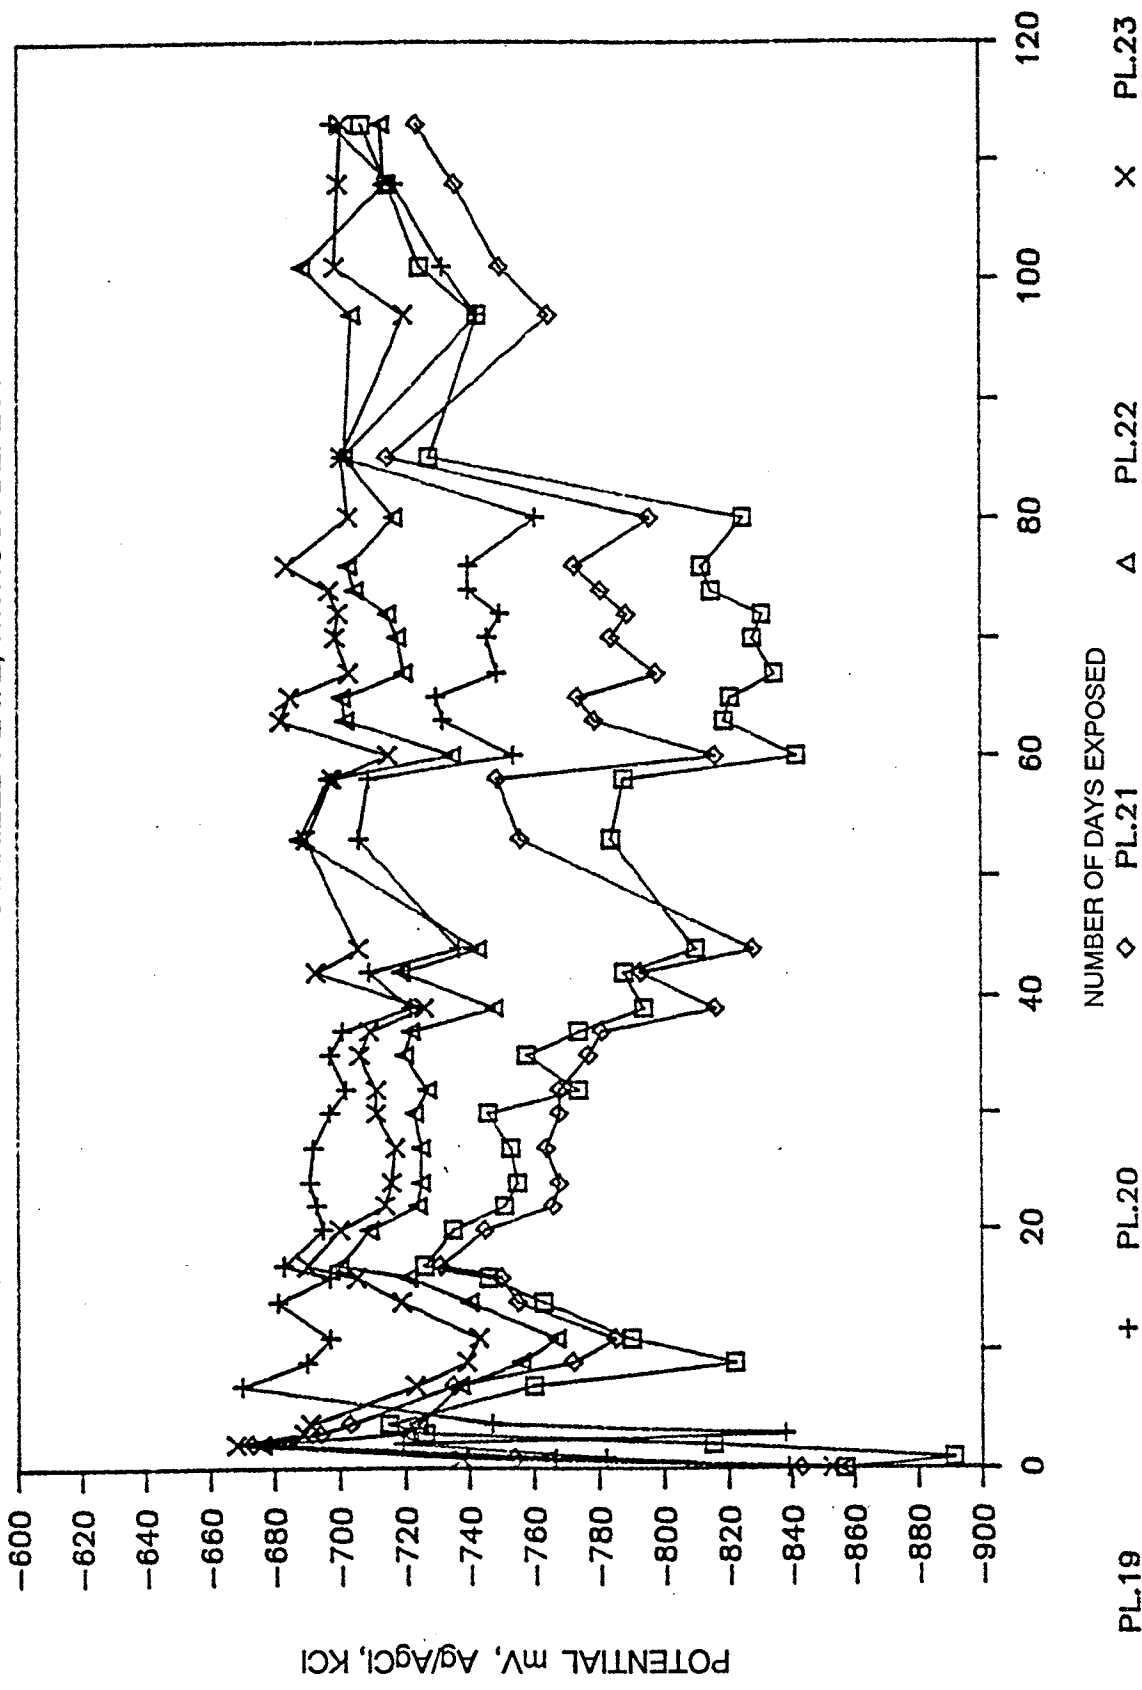
NORWEGIAN MARINE TECHNOLOGY RESEARCH INSTITUTE A/S	PROJECT NO.
	REPORT NO.
	FIGURE NO. 18

# MEASURING OF POTENTIAL, AI-NAME PLATES

POTENTIODYNAMICALLY POLARIZED PLATE, WITHOUT DEFECT

The aluminium plates which were exposed under free corrosion showed potential values in the region from –840 to –620 mV with an average of approximately –720 mV (see figures 7 – 14 + figure 18).

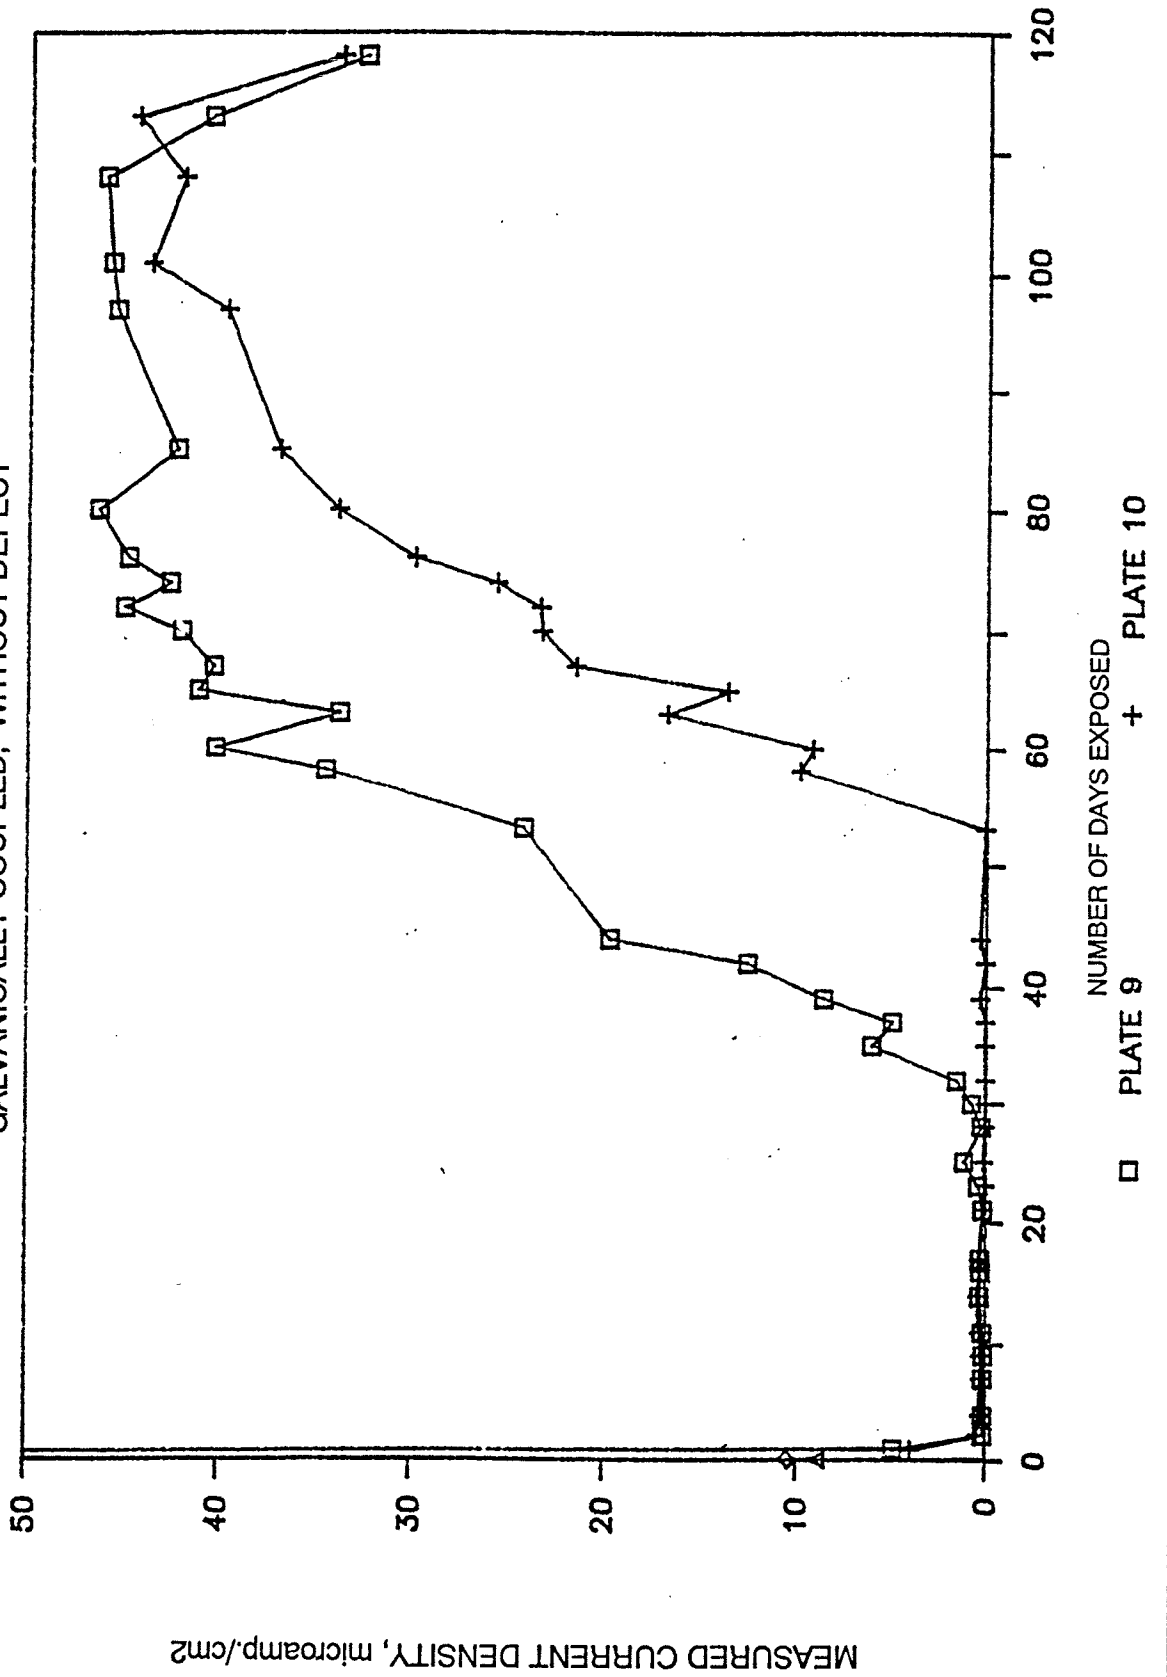
NORWEGIAN MARINE TECHNOLOGY RESEARCH INSTITUTE A/S	PROJECT NO.
	REPORT NO.
	FIGURE NO. 19

# MEASURING OF CURRENT DENSITY, AI-NAME PLATES

GALVANICALLY COUPLED, WITHOUT DEFECT

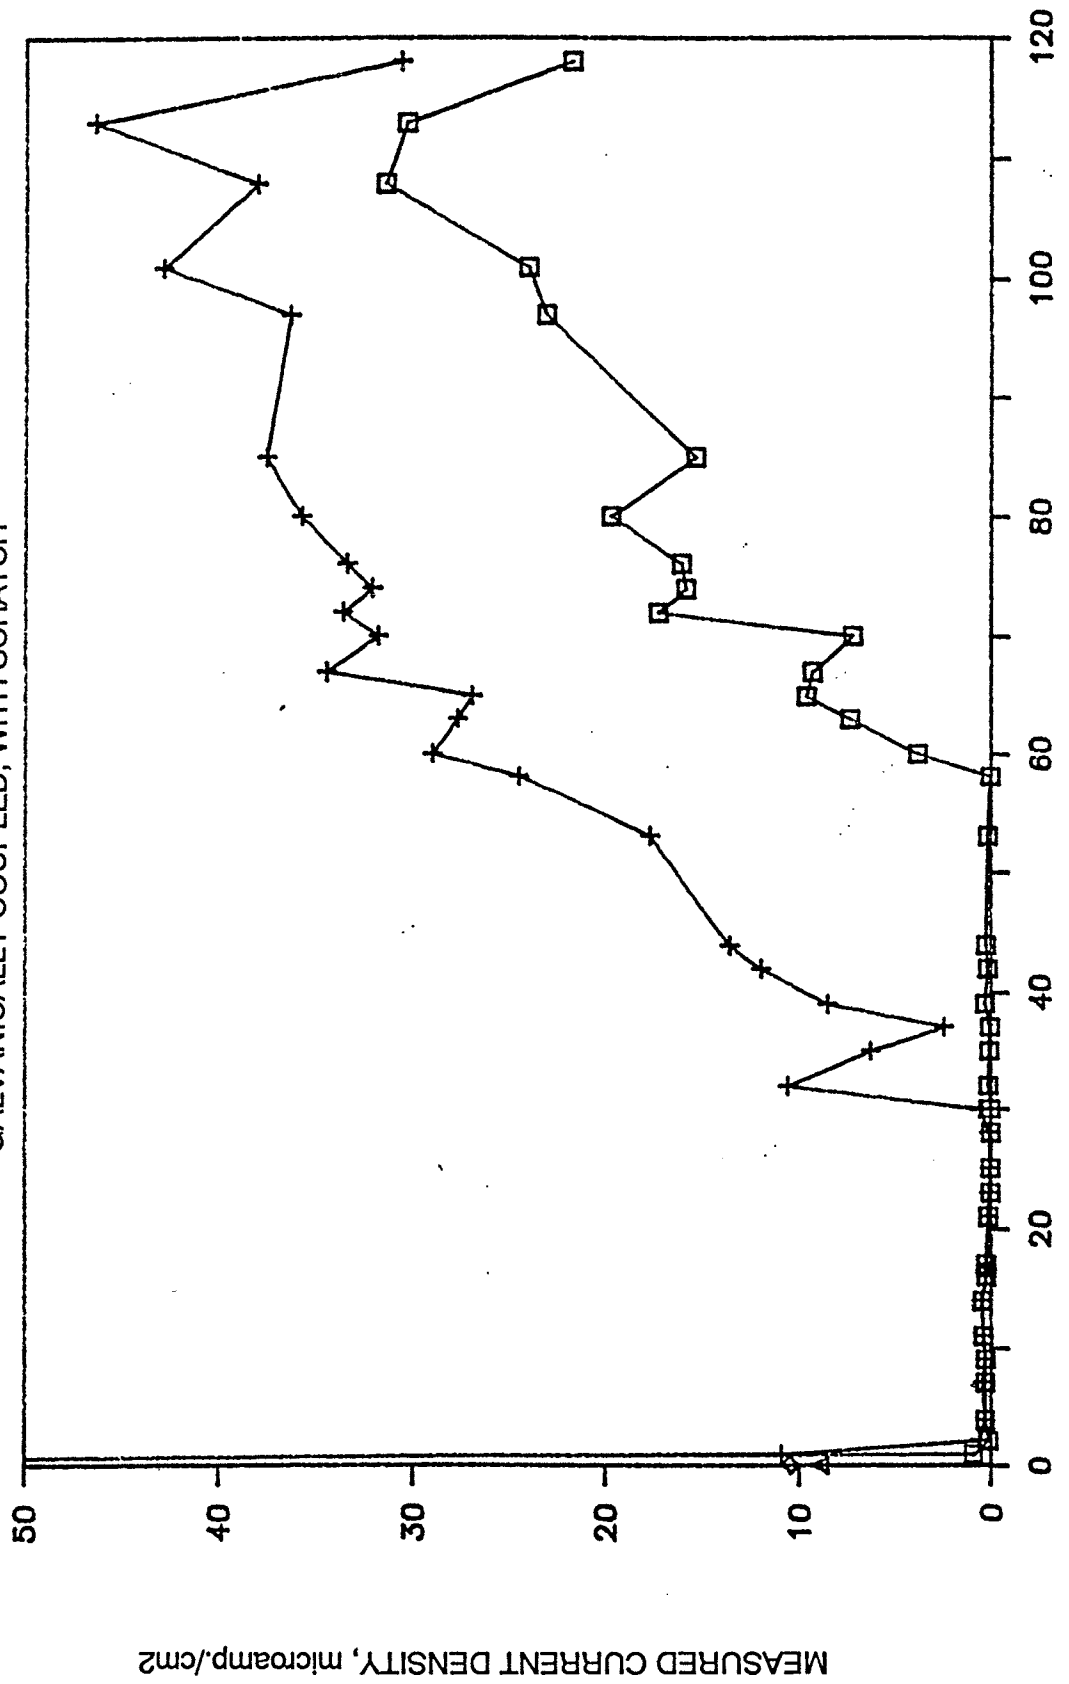
NORWEGIAN MARINE TECHNOLOGY RESEARCH INSTITUTE A/S	PROJECT NO.
	REPORT NO.
	FIGURE NO. 20

# MEASURING OF CURRENT DENSITY, AI-NAME PLATES

GALVANICALLY COUPLED, WITH SCRATCH

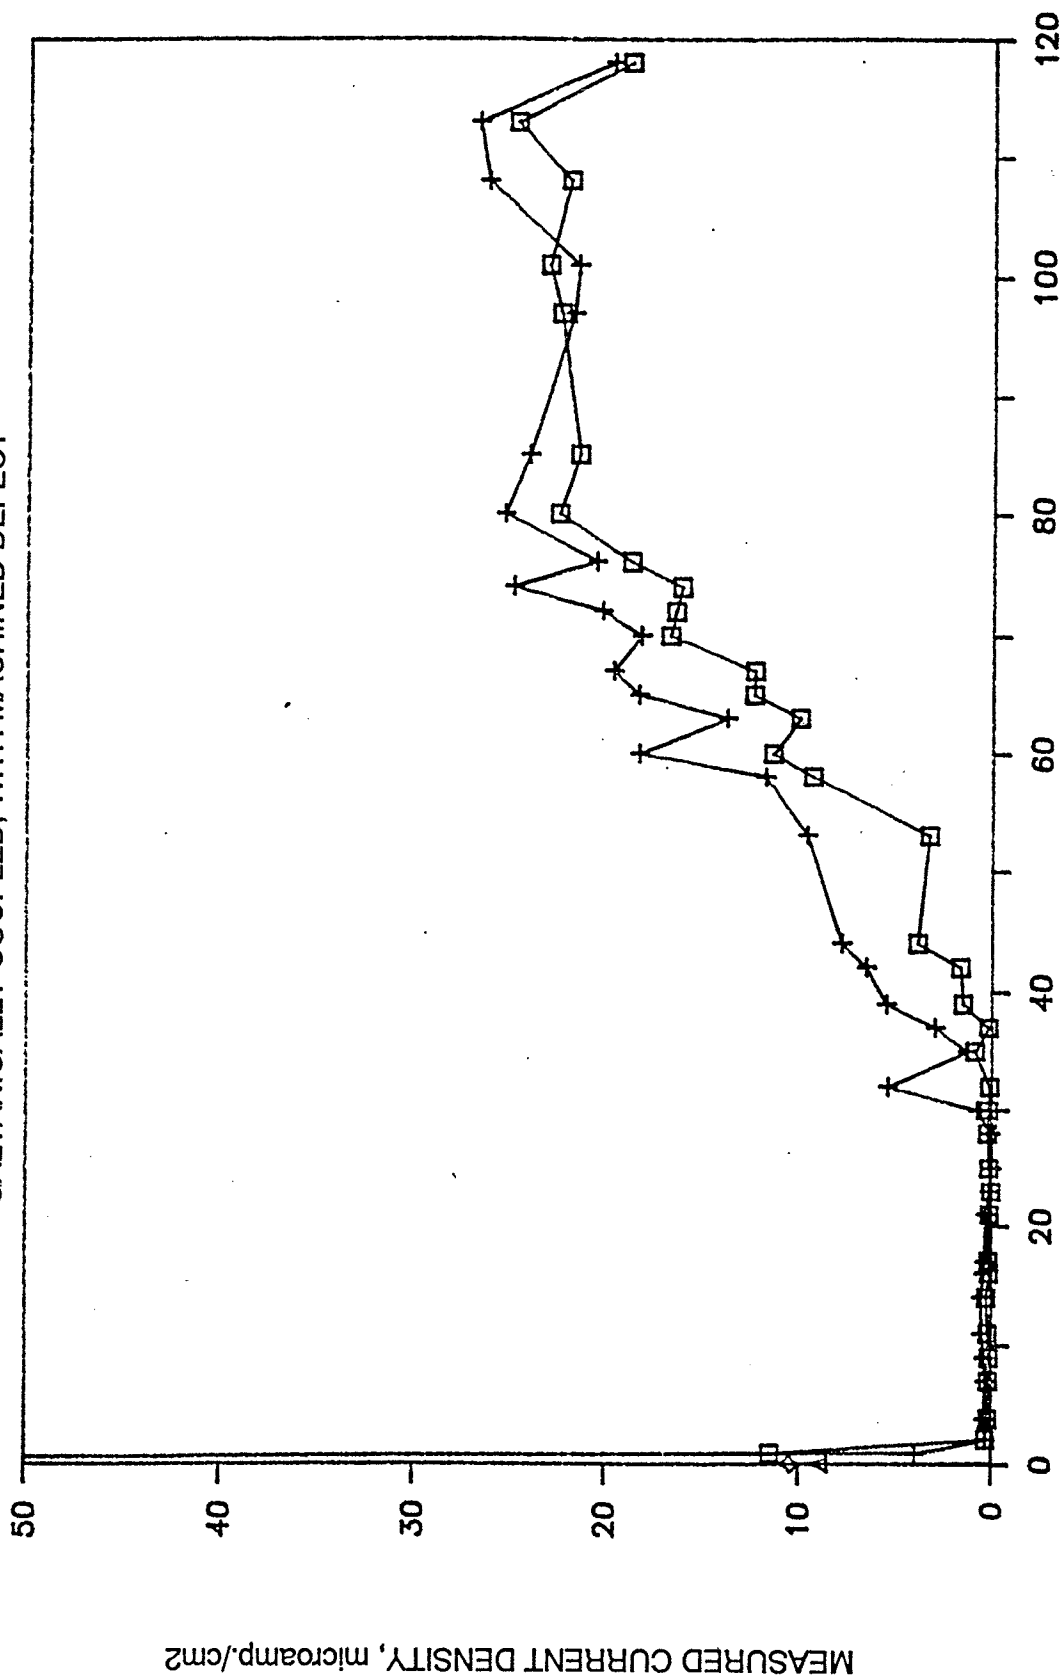
NORWEGIAN MARINE TECHNOLOGY RESEARCH INSTITUTE A/S	PROJECT NO.
	REPORT NO.
	FIGURE NO. 21

# MEASURING OF CURRENT DENSITY, AI-NAME PLATES

GALVANICALLY COUPLED, WITH MACHINED DEFECT

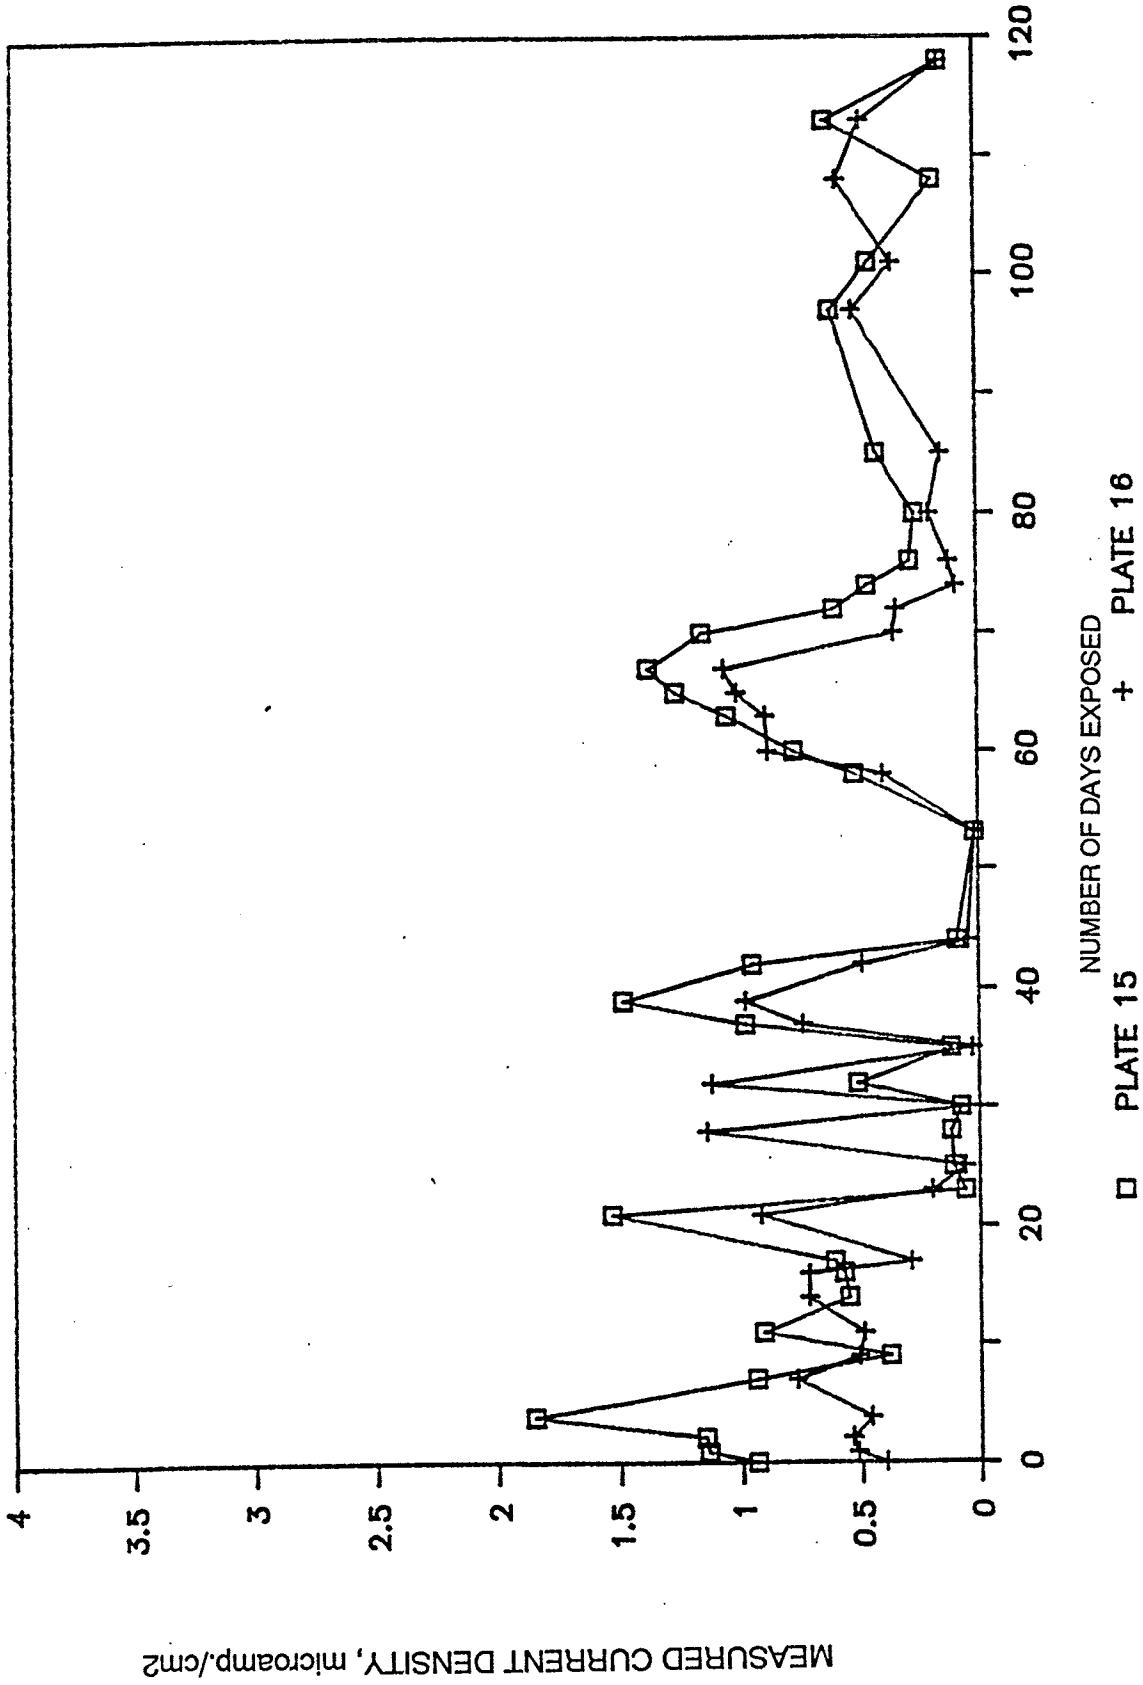
NORWEGIAN MARINE TECHNOLOGY RESEARCH INSTITUTE A/S	PROJECT NO.
	REPORT NO.
	FIGURE NO. 22

# MEASURING OF CURRENT DENSITY, AI-NAME PLATES

POLARIZED: -800 mV, Ag/AgCl, KCl, WITHOUT DEFECT

Figures 22 – 23 show the current density development for plates polarized to  $-800$  and  $-1050$  mV respectively. The current density curves do not represent any corrosion but the protective current that prevents the plates from reaching their natural free corrosion potential. Like the curves show it takes more current to polarize the plates all the way down to  $-1050$  mV than it takes for a polarization to  $-800$  mV.

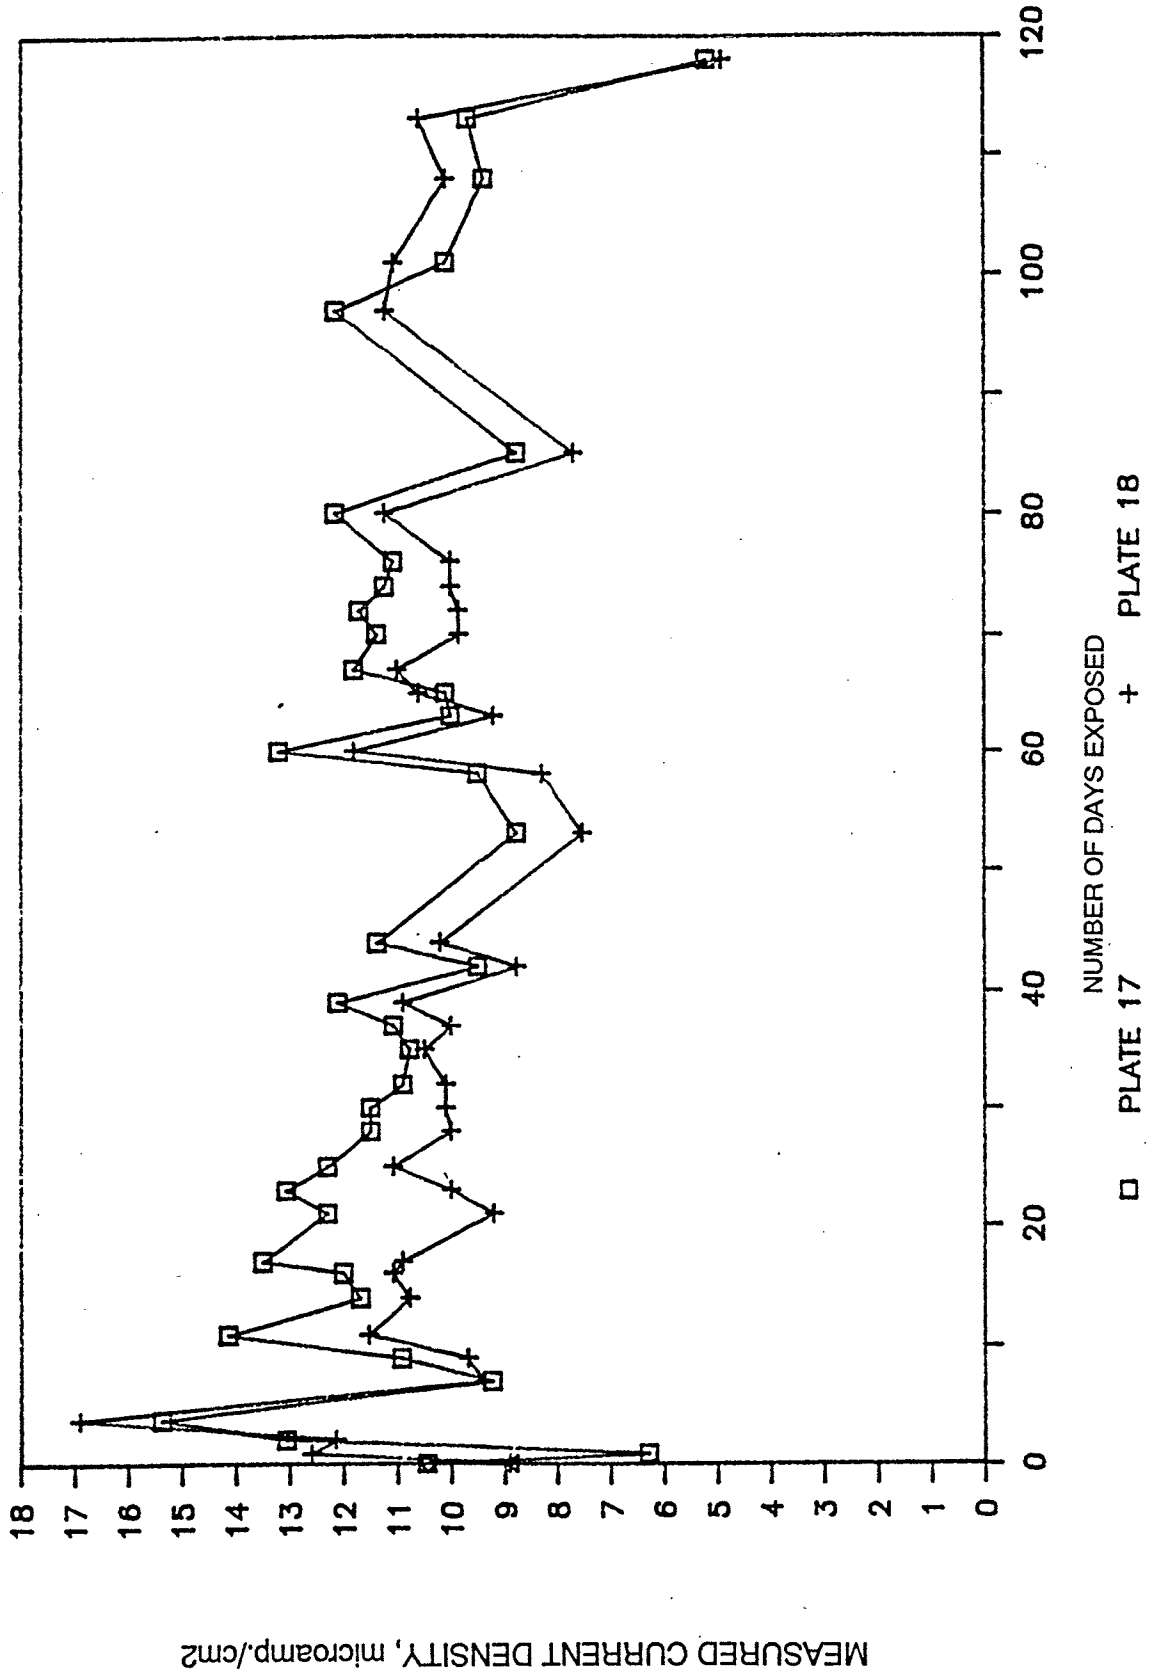
NORWEGIAN MARINE TECHNOLOGY RESEARCH INSTITUTE A/S	PROJECT NO.
	REPORT NO.
	FIGURE NO. 23

# MEASURING OF CURRENT DENSITY, AI-NAME PLATES

POLARIZED: -1050 mV, Ag/AgCl, KCl, WITHOUT DEFECT

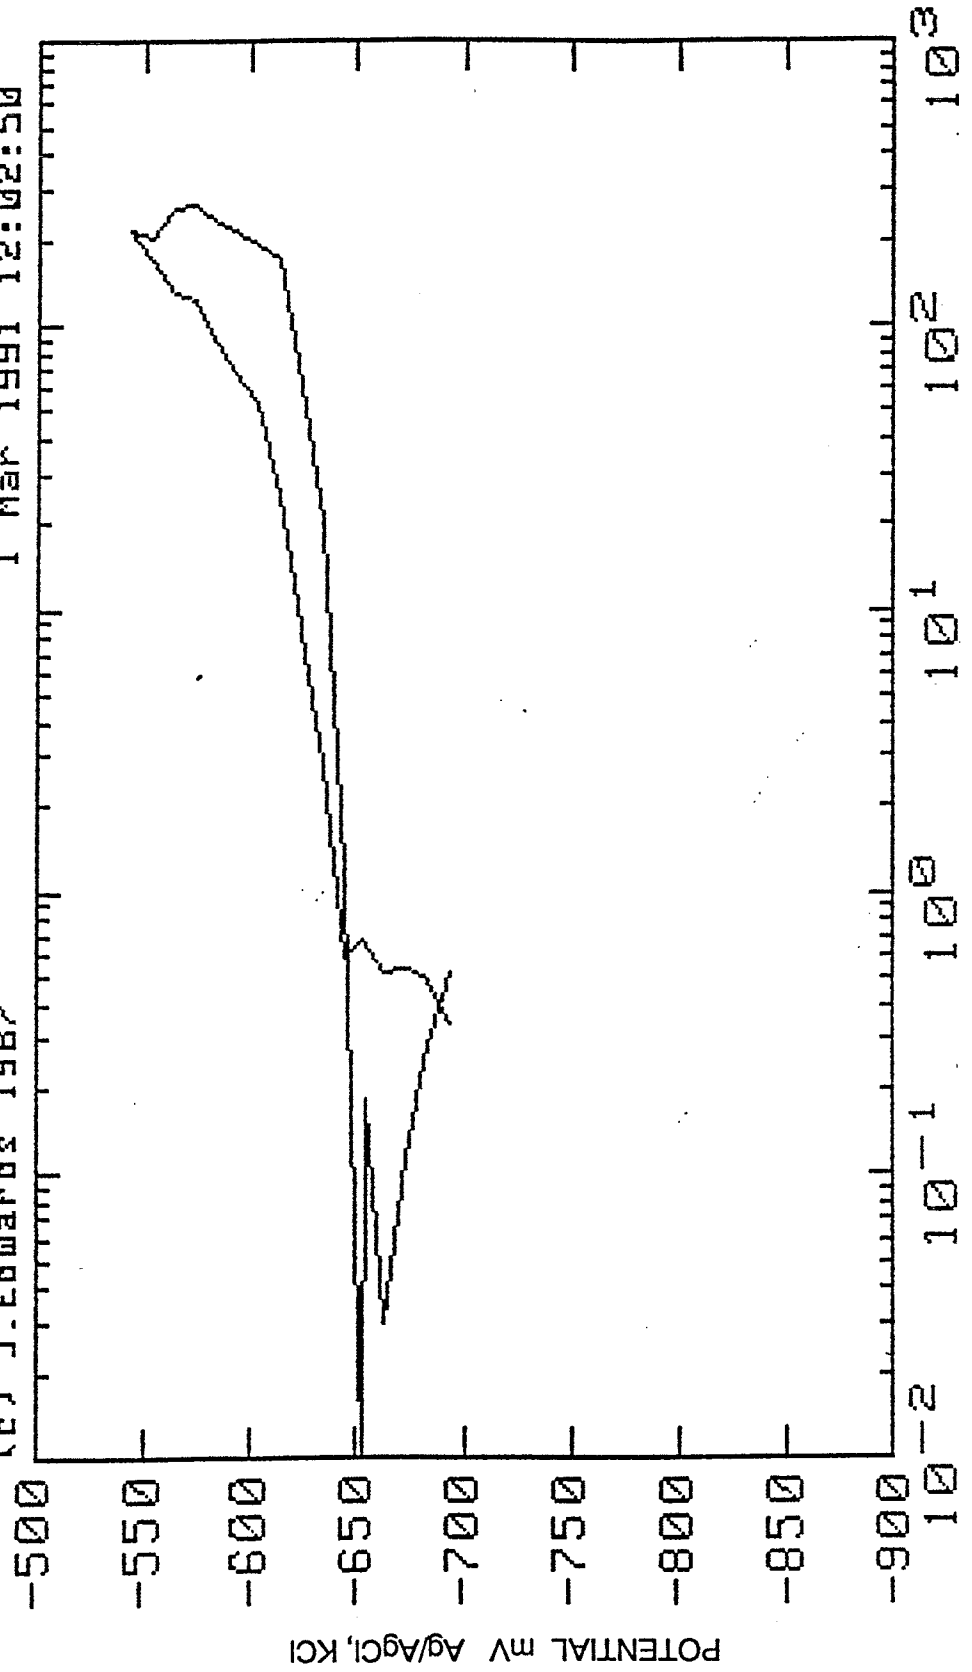
# ANODIC POLARIZATION CURVE, PLATE 22

The loss of weight is somewhat greater for these plates than for the other freely exposed ones, approx. 300 mg. The explanation for this is that these plates mainly must be looked upon as freely exposed plates. One must then take into account certain individual differences in weight loss as is the fact for the other freely exposed plates. For the plates that were polarized anodically it means that this polarization can cause pit corrosion initiation. For the plates that were subjected to cathodic polarization pitting will not be initiated but a local increase of the pH value will result in slightly higher pitting corrosion rates. If we look at the current density curves for these plates one can from the anodic polarization curves (figures 24 – 25) note that the current density increases strongly at a potential of approx.  $-670\ \text{mV}$ . This is the so called pitting potential.

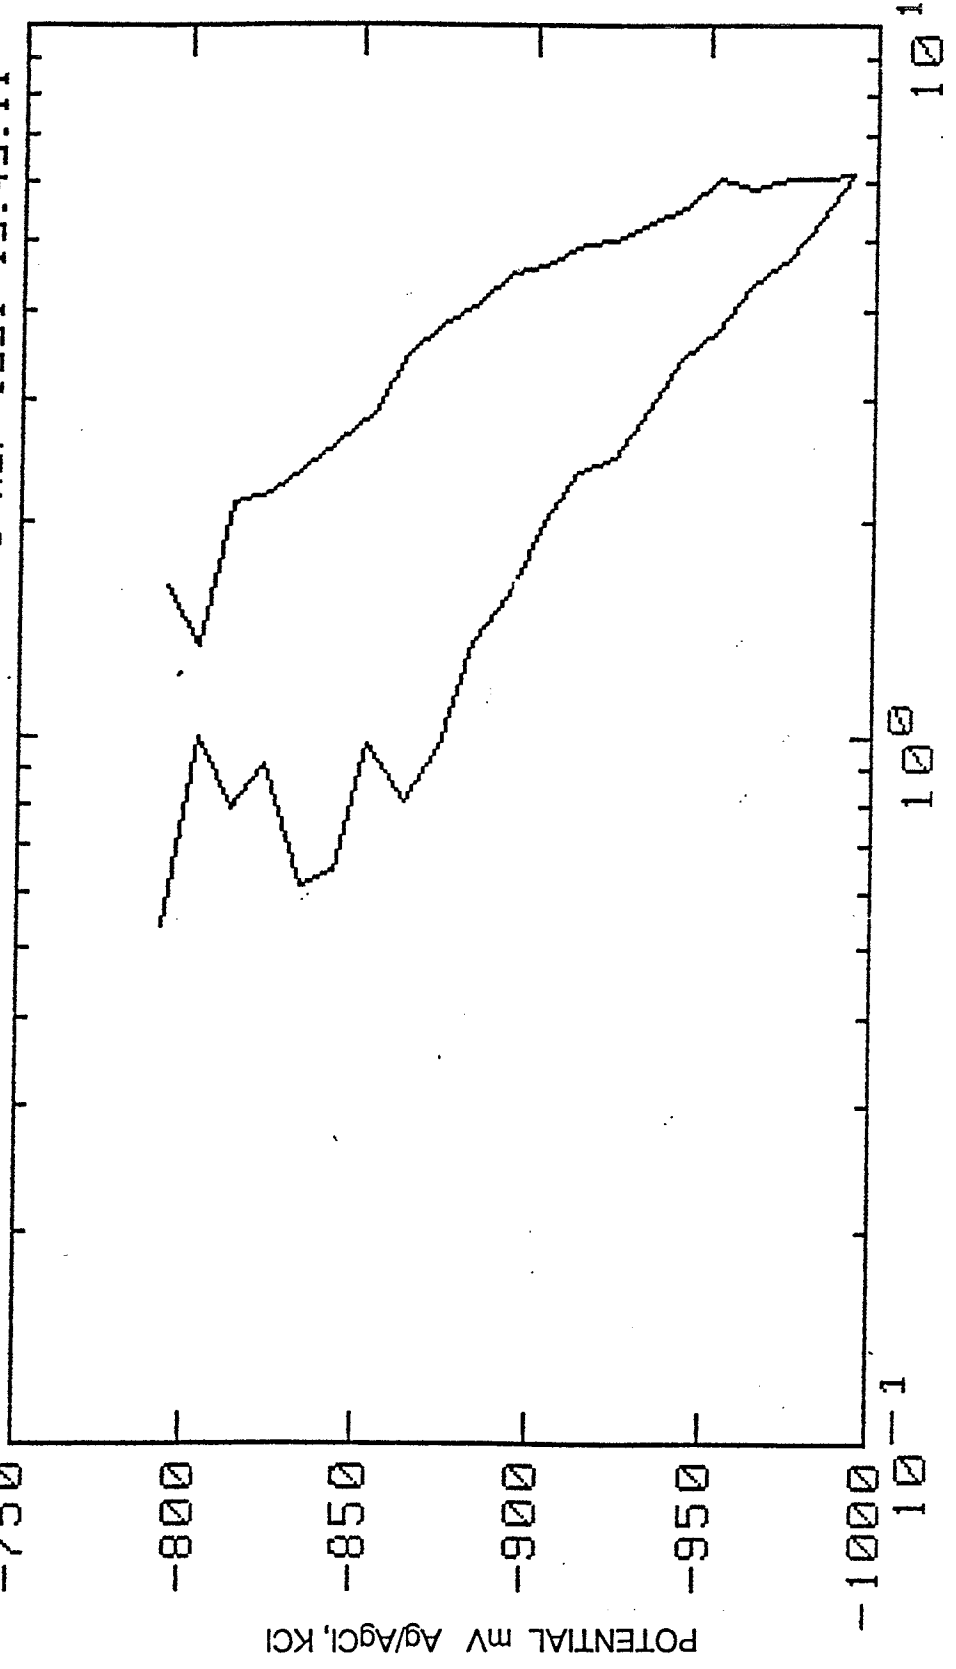
NORWEGIAN MARINE TECHNOLOGY RESEARCH INSTITUTE A/S	PROJECT NO.
	REPORT NO.
	FIGURE NO. 26

# CATHODIC POLARIZATION CURVE, PLATE 21

Figures 26 – 27 show the current density for the cathodically polarized plates. Like the curves show the current density does not increase to any extent worth mentioning at a continued polarization after the potential has reached approx.  $-1000\ \text{mV}$ . Here the limiting current for oxygen reduction has been reached. Such a limiting current is characteristic for the maximum corrosion rate that a material can have in a given environment where the oxygen reduction is the rate setting step.

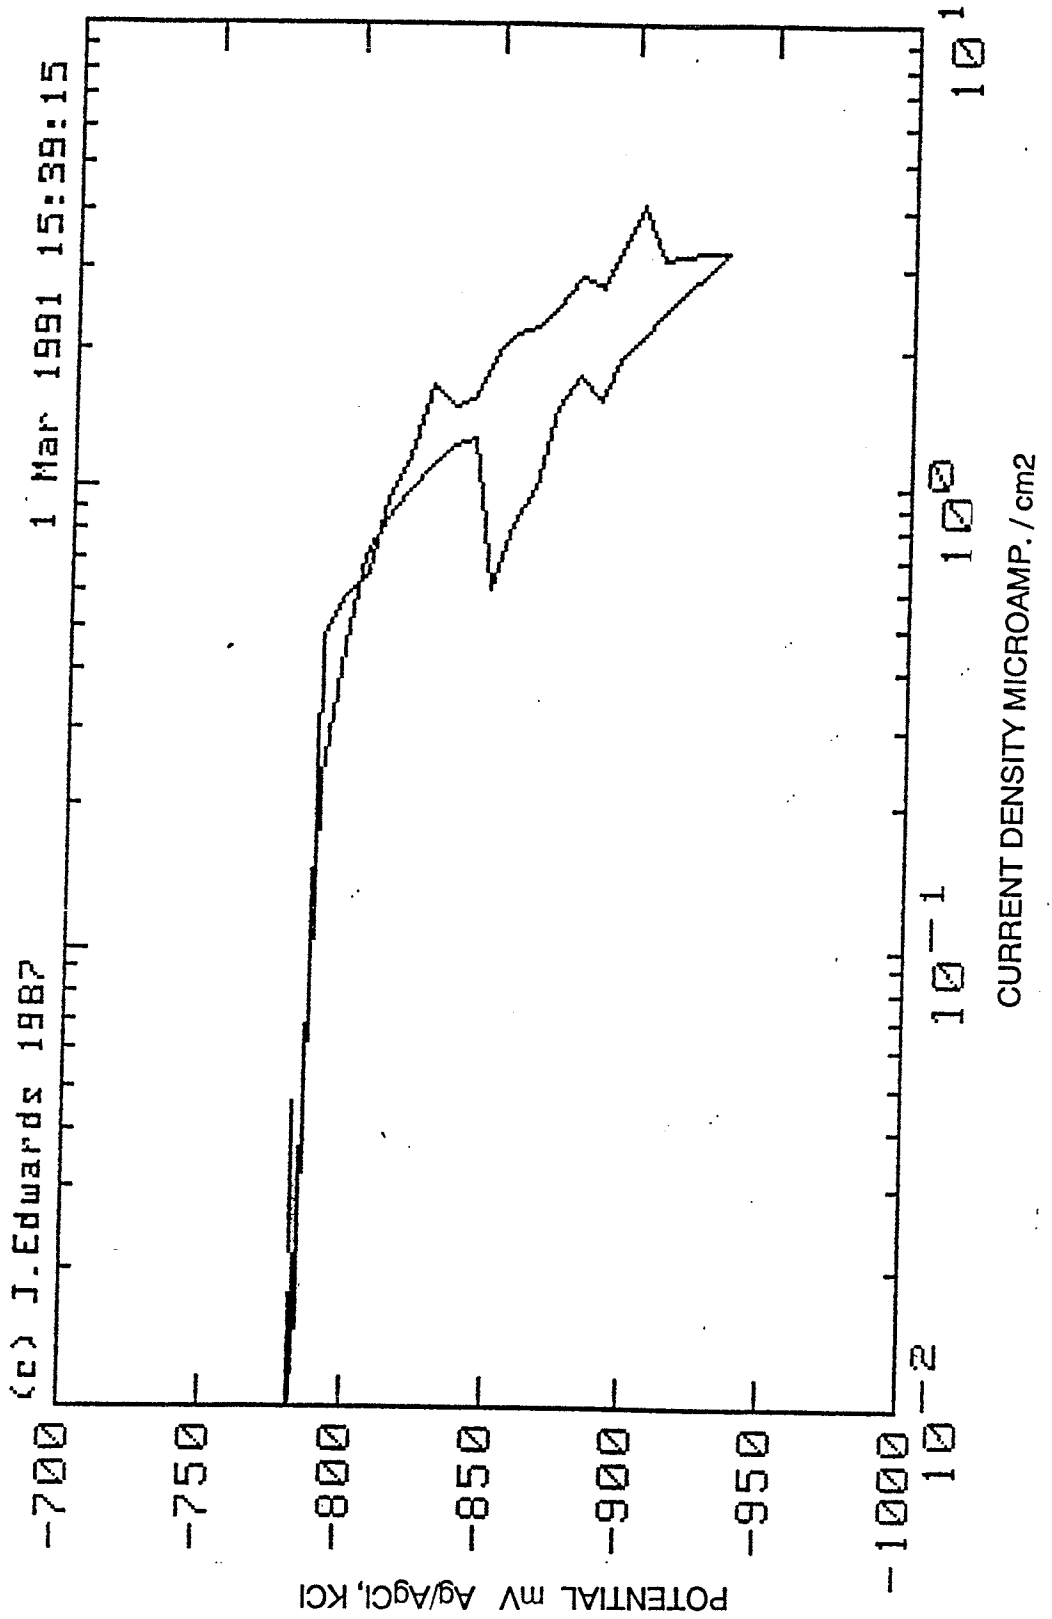
NORWEGIAN MARINE TECHNOLOGY RESEARCH INSTITUTE A/S	PROJECT NO.
	REPORT NO.
	FIGURE NO. 27

# CATHODIC POLARIZATION CURVE, PLATE 23

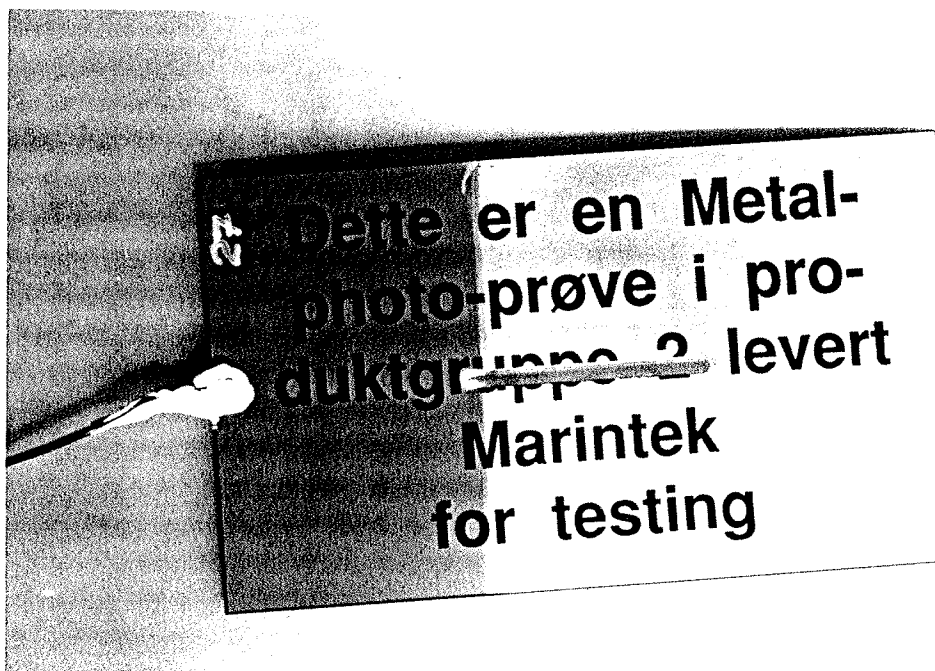
Photograph 3: Plate No 27 with a ground defect, partly submerged in sea water. Corrosion conditions along the edges and in the ground defect are representative for all plates that were exposed to sea water and that were not coupled steel.

The loss of weight was naturally a little less, approx. 170 mg. The reason for this being that corrosion only takes place on the submerged part of the plate. Due to this fact the area where corrosion can take place is smaller and therefore the loss of weight smaller on a partly submerged plate than on the completely submerged ones (see photograph 3).

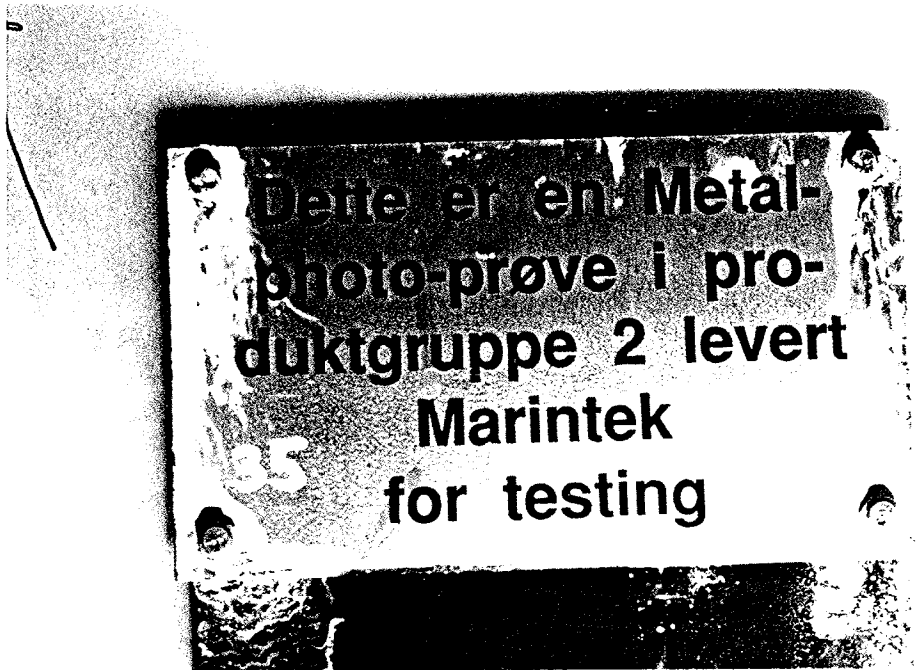
Photograph 6: Plate No 35, exposed in salt spray chamber; mounted plate.

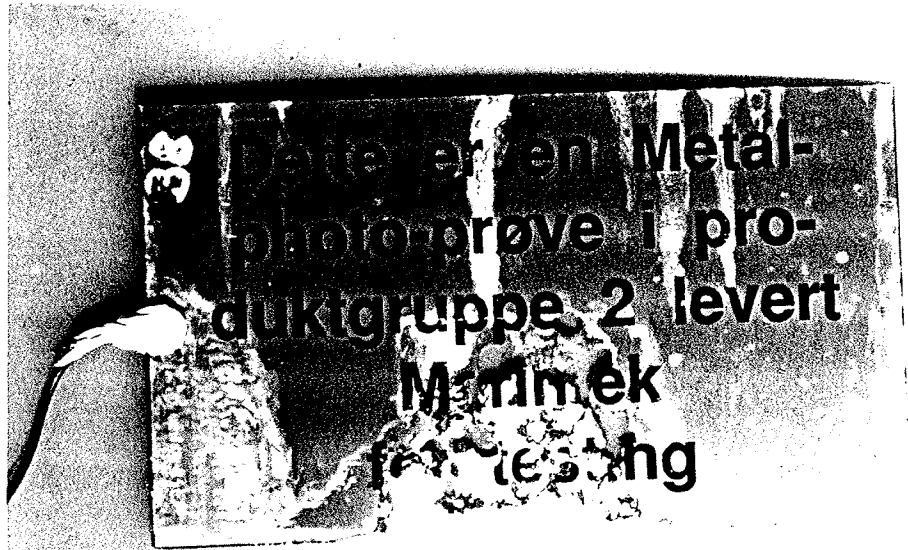
Photograph 7: Plate No 38, exposed in salt spray chamber; galvanically coupled to steel.

The rest of the plates in the salt spray chamber were galvanically connected so that an aluminium name plate and a steel plate were placed against each other in such a way that they formed a "V". These plates had a very high loss of weight and are partly perforated by corrosion where the aluminium was in contact with the steel. This shows that the mounting of the name plates and the evaluation of the corrosion environment are extremely important to achieve a satisfying life for the name plates (*see photograph 7*) (*compare comments in chapter 6.1.*).
